Archaeological Investigations at Saintbury, Gloucestershire

By Duncan Wright, Scott Chaussée, Oliver Creighton, David Gould,
Tim Kinnaird, Michael Shapland, Aayush Srivastava, and Sam Turner

June 2024

ARCHAEOLOGICAL INVESTIGATIONS AT SAINTBURY, GLOUCESTERSHIRE

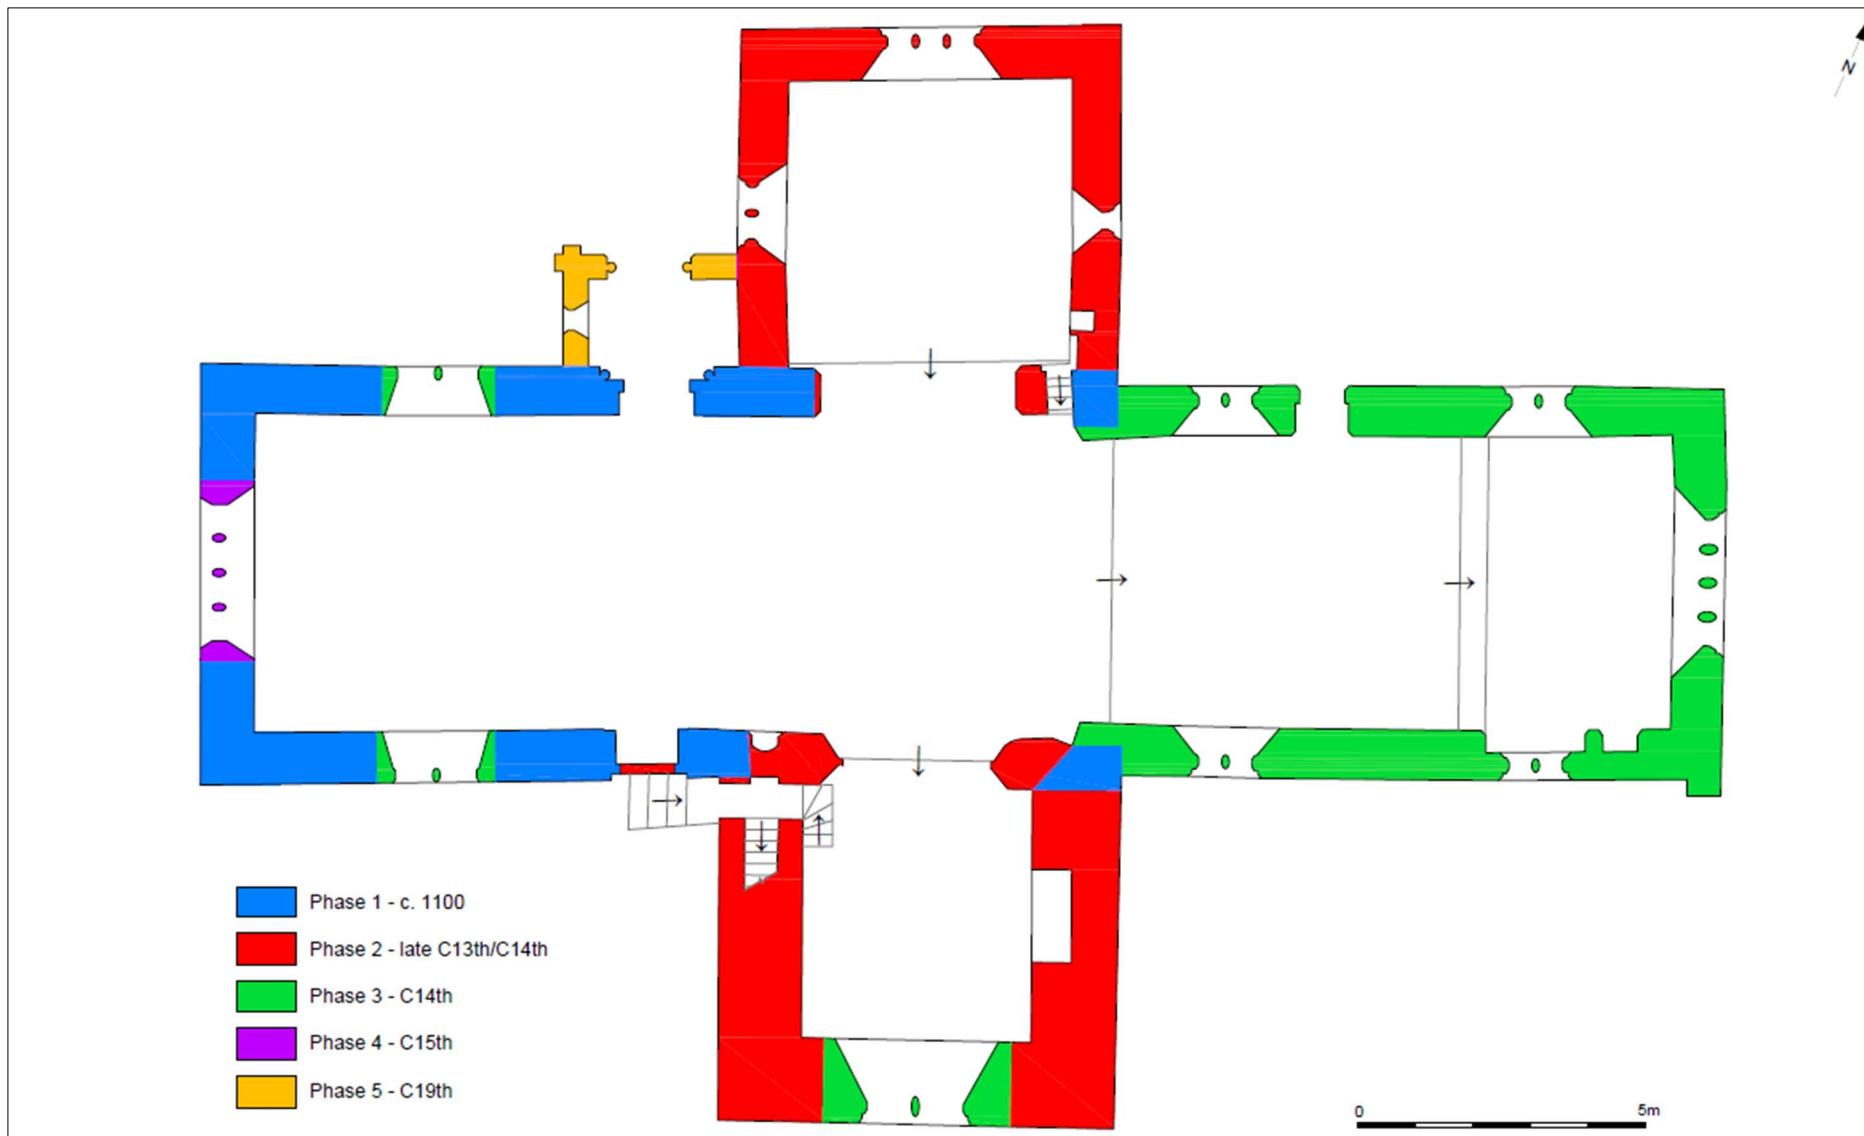
Figure 6: Indicative phase plan of St Nicholas' Church, Saintbury.

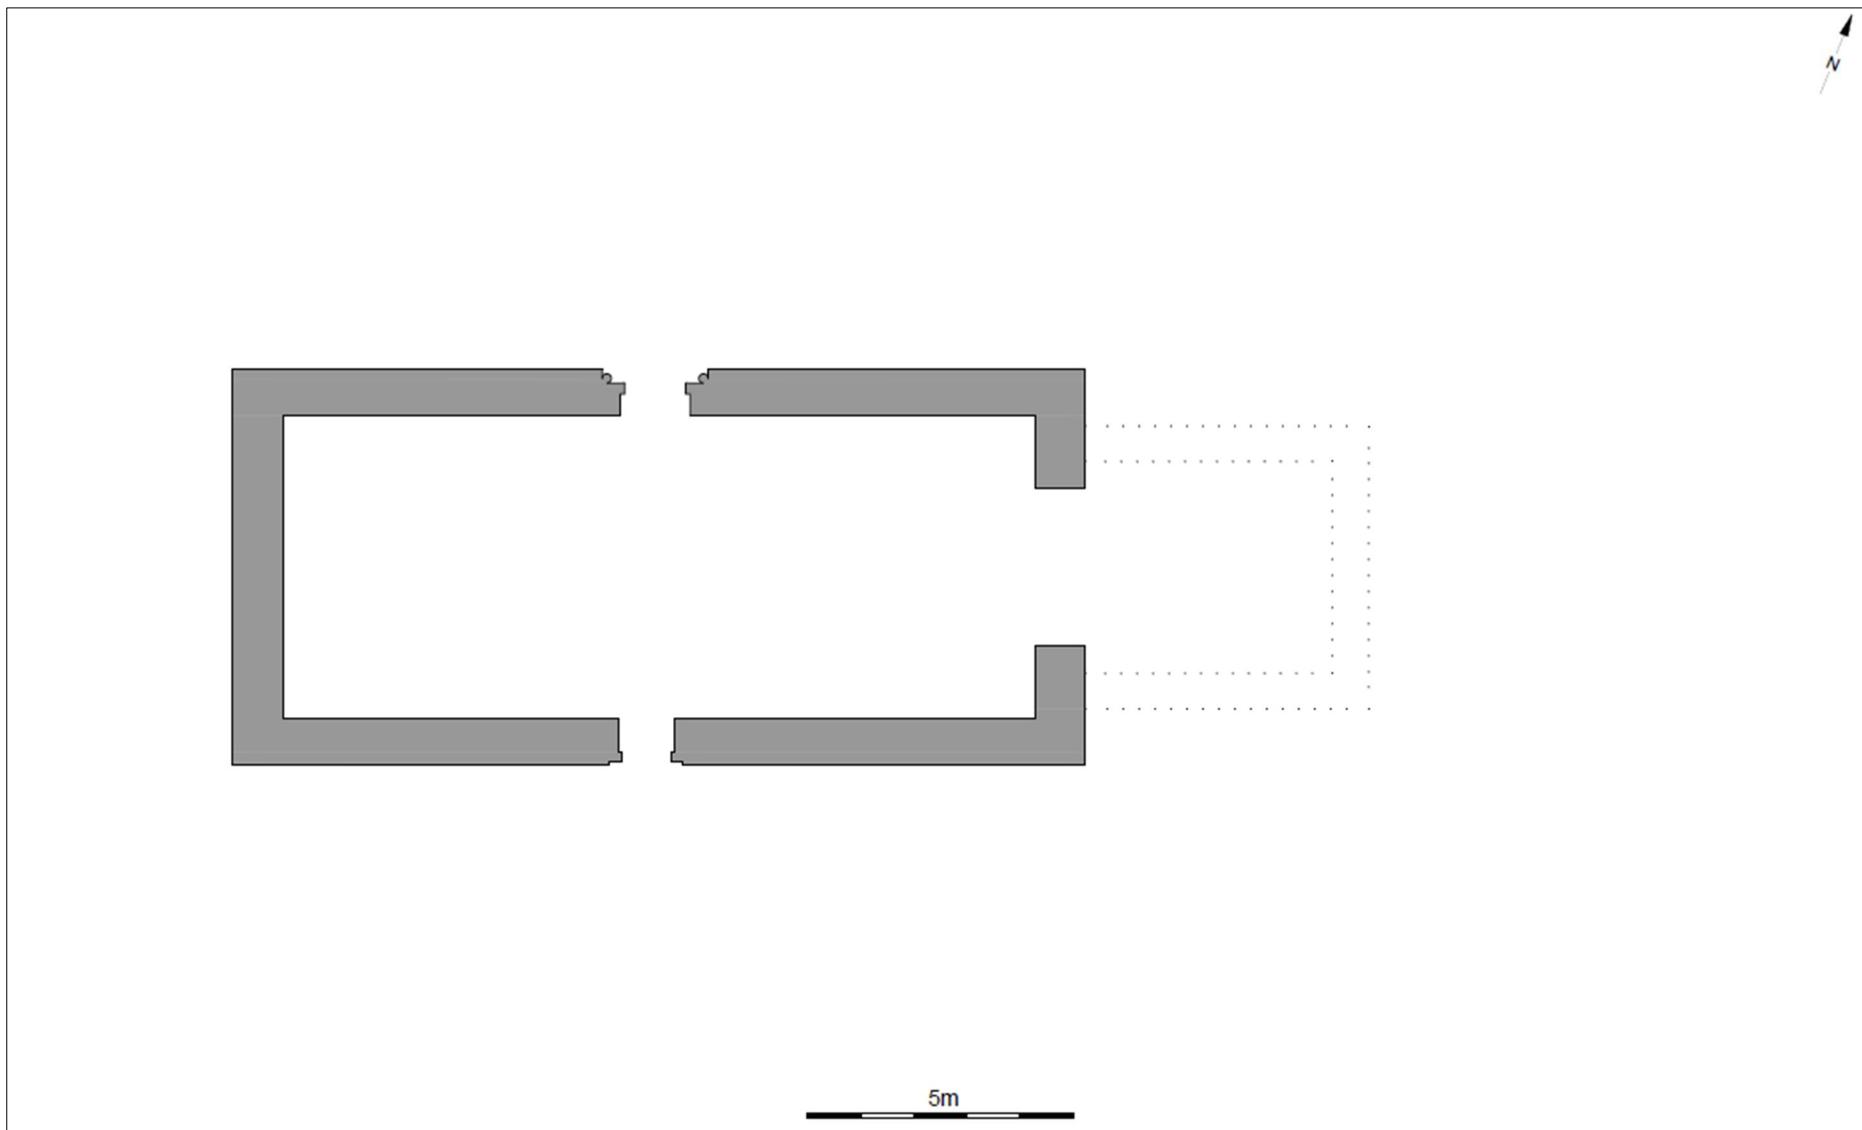
Figure 9: Reconstruction plan of Phase I of St Nicholas' Church, Saintbury.

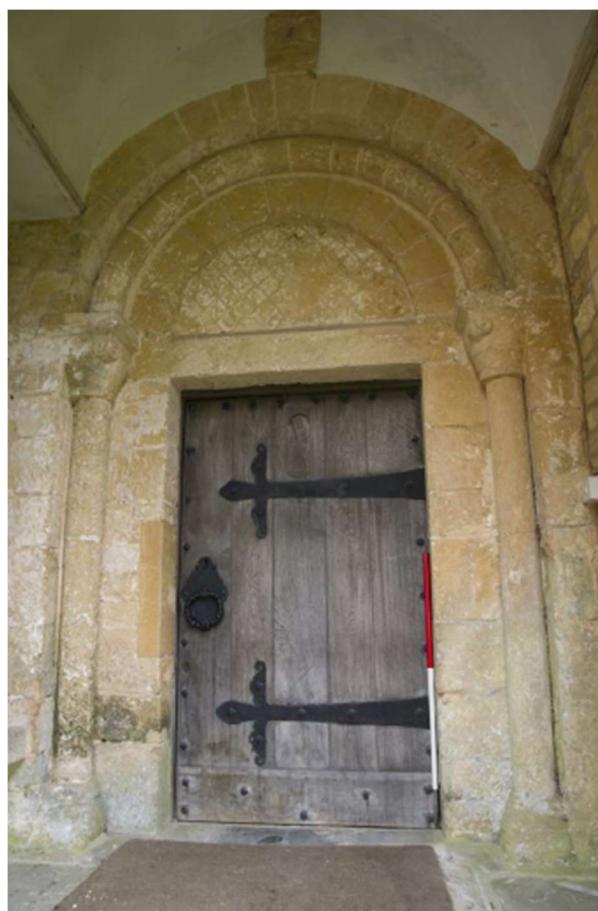
Figure 16: North doorway, general view looking south.

The outstanding surviving feature of the Norman nave is the north doorway, which lies midway along the nave wall (Figure 16). This is round-headed, of two orders, and constructed from well-dressed stone. The outer order is flanked by a pair of engaged columns with volute cushion capitals and round shafts: the shaft of the western column is richly ornamented with chevrons interspersed with roundels, whilst the eastern shaft is plain. The square column-bases were formerly gently stepped, and topped by a thick torus. The columns support a bulky roll-moulding between the outer order of voussoirs and the inner, which springs from a pair of chamfered imposts. The doorway's inner order has a semi-circular tympanum bearing incised lozenges. Above the doorway is a contemporary grotesque male face with prominent eyes, cheeks and nose (Figure 17). The opposing south doorway to the nave is also original, and of comparable design, although much plainer (Figure 18). It is round-headed, of two orders, but lacks the engaged columns of its northern counterpart. The outer order of voussoirs spring from a pair of chamfered imposts, and the shallow inner order has another tympanum, very similar to its northern counterpart, bearing incised lozenges. The doorway is surmounted not by a grotesque face but a circular sundial, which may not be original to the fabric of the wall (Bryant 2012).

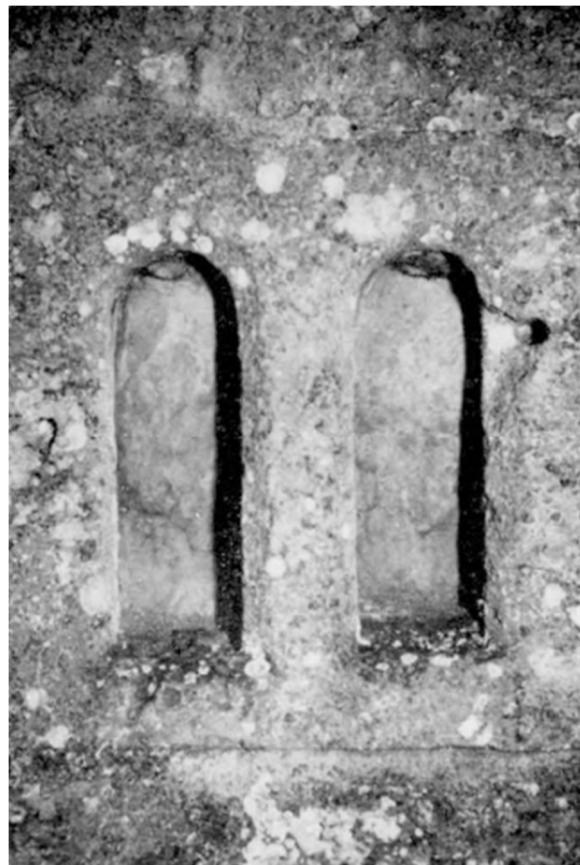
Figure 19: Two-light megalithic window formerly located within the church (Mackay 1963). The current location is unknown.

In terms of windows, the only coherent example known from the church was removed in antiquity, and was reported in 1963 as being in the gable end of a nearby cottage (Figure 19) (Mackay 1963, 94). Efforts to locate this window in the village were unsuccessful. It took the form of a two-light window cut from a single block of stone: each light is round-headed, and bears a continuous chamfer. Single-light windows cut from single large stones are a feature of the area, with some dating to the sixteenth century, although this two-light example is less common, and convincingly early. A comparable two-light window with splayed jambs and round heads is known in the county at Daglingworth; rebuilt into a later medieval phase of the Church of the Holy Rood, the piece is formed from a re-used Roman altar (Mackay 1963, 81; Taylor & Taylor 1965, 189). Neither window is included in *The Corpus of Anglo-Saxon Stone Sculpture*, although the Daglingworth example has been suggested as pre-Conquest. Indeed, megalithic and through-stone windows are particularly characteristic of Anglo-Saxon architecture, especially where both the head and jambs are formed this way (Taylor & Taylor, 1965, 189; Taylor 1978, 836, 847). Further potential evidence for an early window takes the form of a possible column capital and drum, re-used high up in the building's western gable end, which was rebuilt in the fifteenth century (Figure 20). These stones are uncertain and not especially diagnostic, but are plausible as the remnant of a two-light window separated by a column — a style particularly characteristic of eleventh- and twelfth-century architecture (Stocker & Everson 2006, 36-44). A fragment of early Norman chevron ornament can also be seen built into the fourteenth-century chancel, but its origin is unknown (Figure 21).

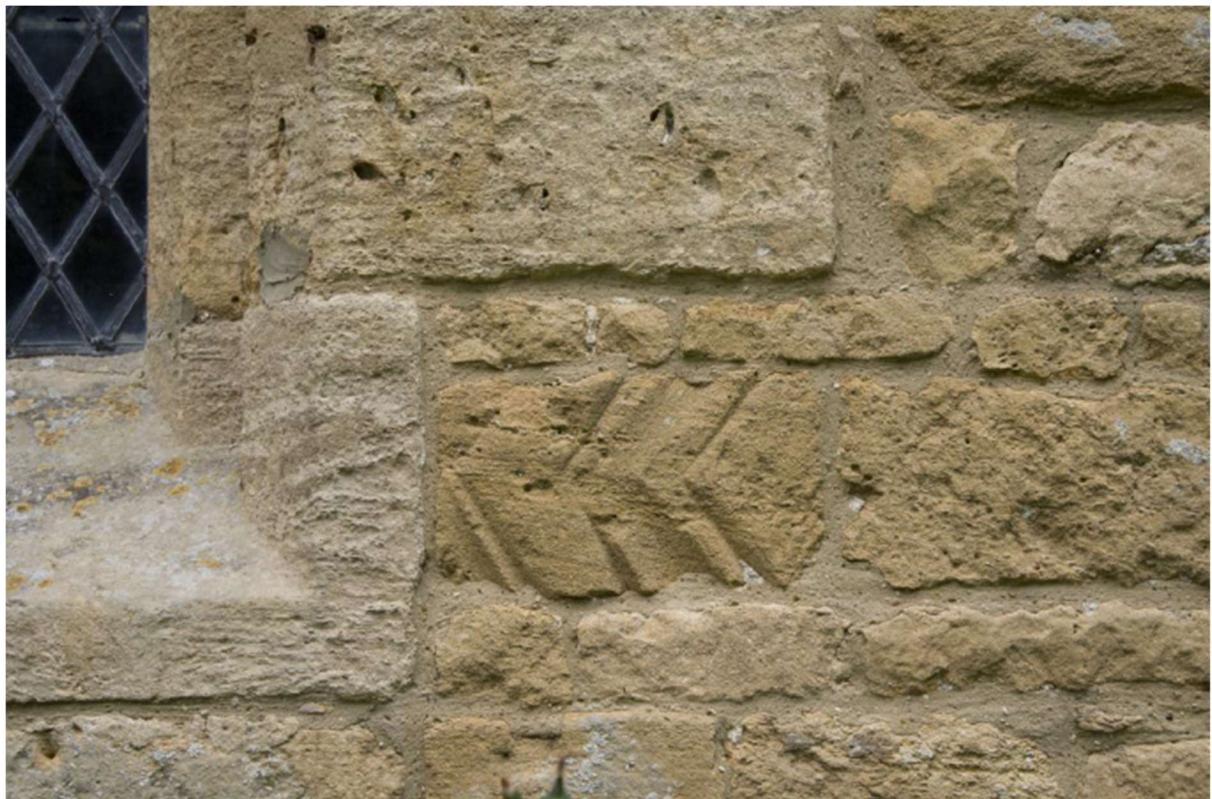
Figure 21: Remnant of chevron ornament re-set into the southern external wall of the chancel.

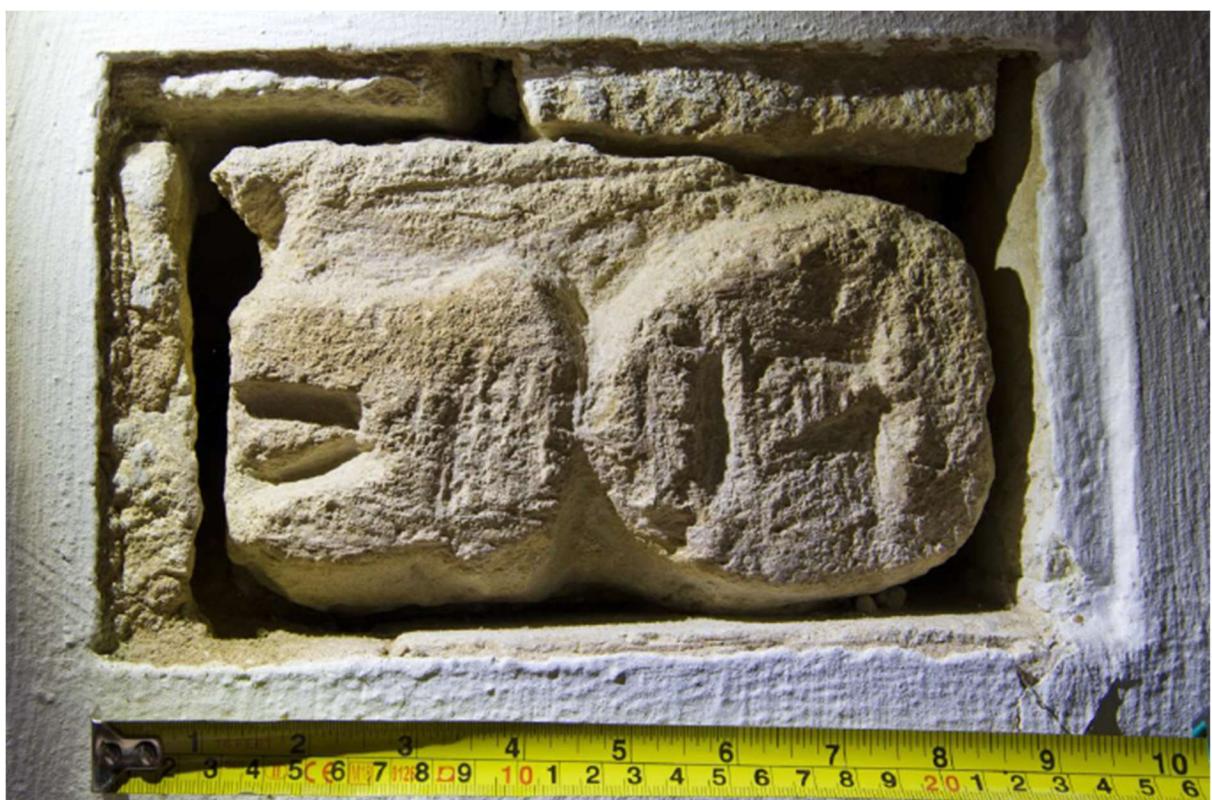
Figure 22: Possible early figurative sculpture re-set into the southern internal wall of the chancel.

One other early feature is a small stone figure with a tiny body, a large head, and stubby arms and legs, and – plausibly – the remains of a cloak or wings (Figure 22). It is re-set into the southern window of the fourteenth-century chancel, where it was deliberately defaced before concealment. It is of undoubtedly early – but uncertain – date, and has been taken as evidence for the existence of a previous stone church on this site (Bryant 2012). Alternatively, the figure may actually be of Roman origin, rather than medieval in date. A second figure of similar type is apparently re-set into the later medieval tower, although this could not be located (McCormick 1960). The remainder of the church (chancel, tower, north transept and porch) are of late thirteenth-century and later date, and will not be discussed here.

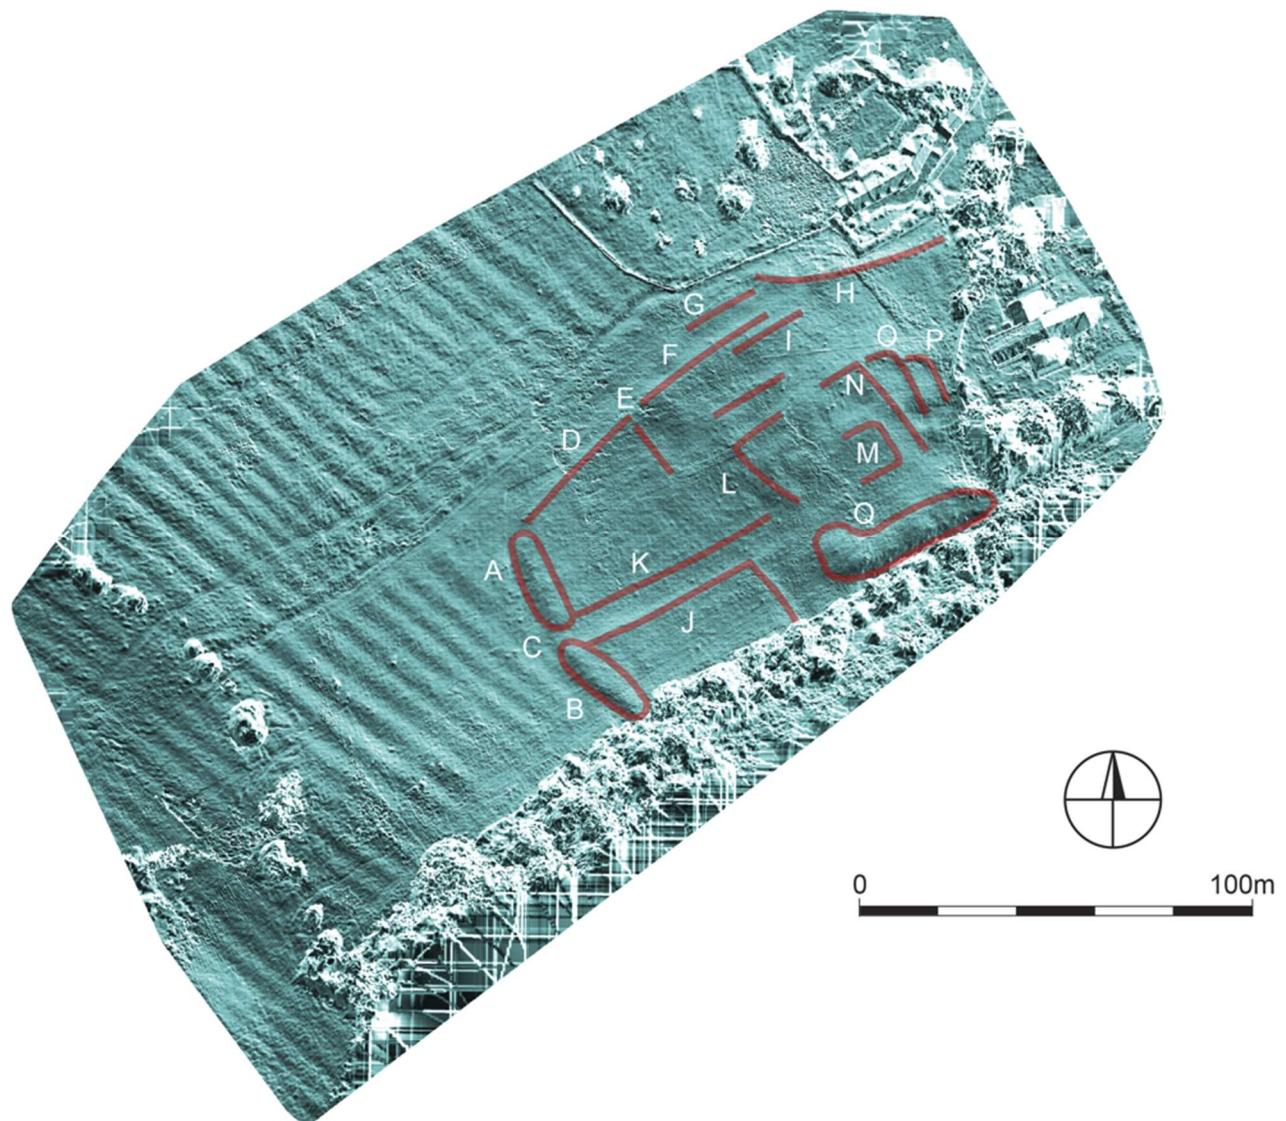
Figure 25: Annotation of positive earthwork features (i.e. banks) identified on the DTM generated by UAV survey.

DTMs generated via the UAV topographic survey provide a far greater resolution of archaeological features than discernible through models derived from publicly accessible LiDAR data (Figures 24-26). An attempt here is made to characterise the most obvious components of the site, especially the positive features (earthwork banks) easily detectable on DTMs and through field observation. The lettering system in the text relates to annotations to the model made in Figure 25.

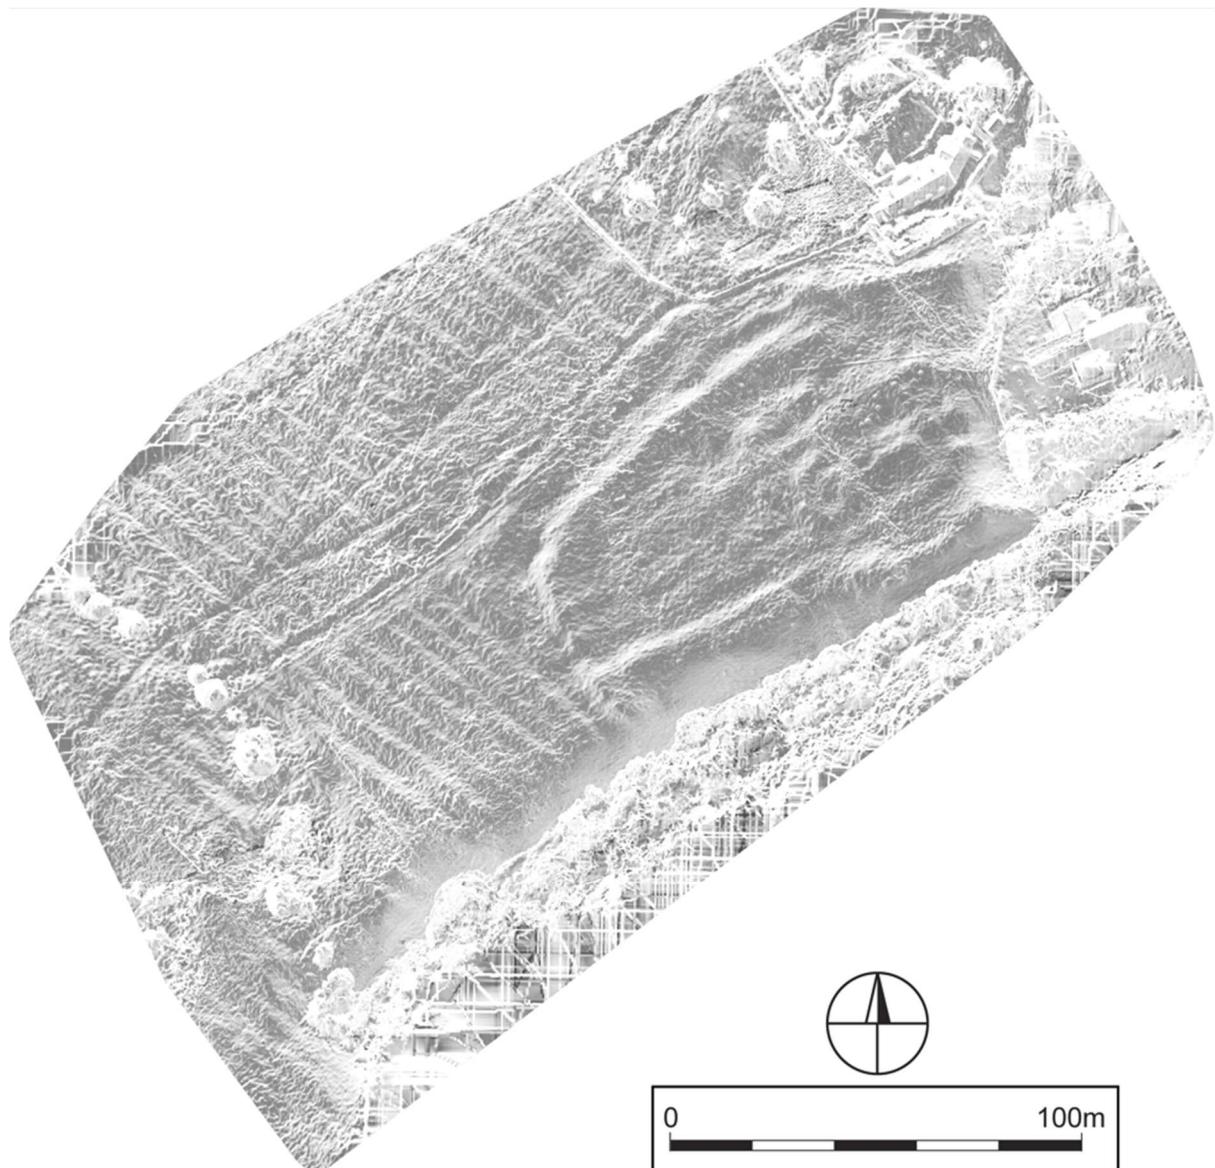
Figure 26: Greyscale DTM with accentuated slope profile. This processing has the advantage of rendering key features more visible, although more subtle variations in the topography can be harder to detect.

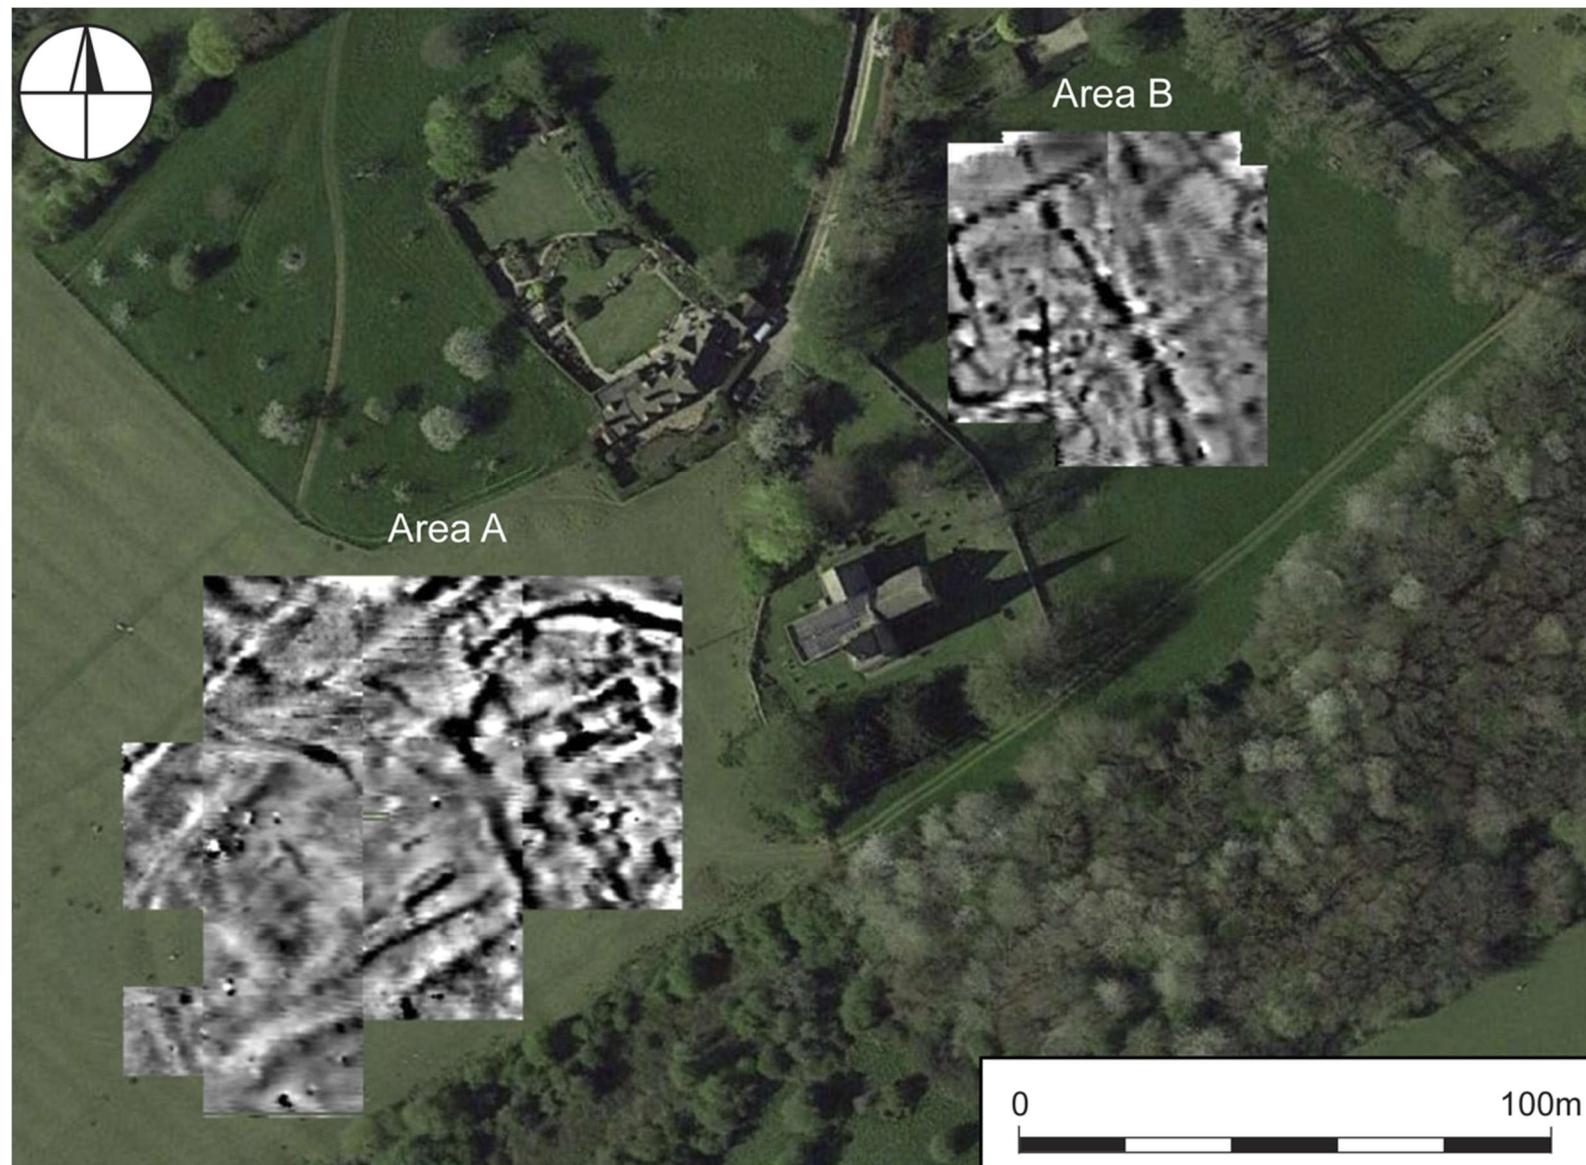
Figure 28: Processed gradiometer plot of the two survey areas either side of St Nicholas' church (centre).

The geophysical survey has identified a number of features that are likely to be representative of archaeological remains (Figures 28-29). The data are displayed at -4 nT (white) to +4 nT (black) for the greyscale plots. The interpretation of the datasets highlights the presence of potential archaeological features as well as deposits of ferrous, burnt, or fired objects which may or may not be archaeological in nature. There are anomalies consistent with disturbance from known and modern sources (such as fences) throughout the dataset. These are not referred to further in this report, unless considered relevant to the archaeological interpretation. It should be noted that small, weakly magnetised features may produce responses that are below the detection threshold of the instrument used. It may be the case

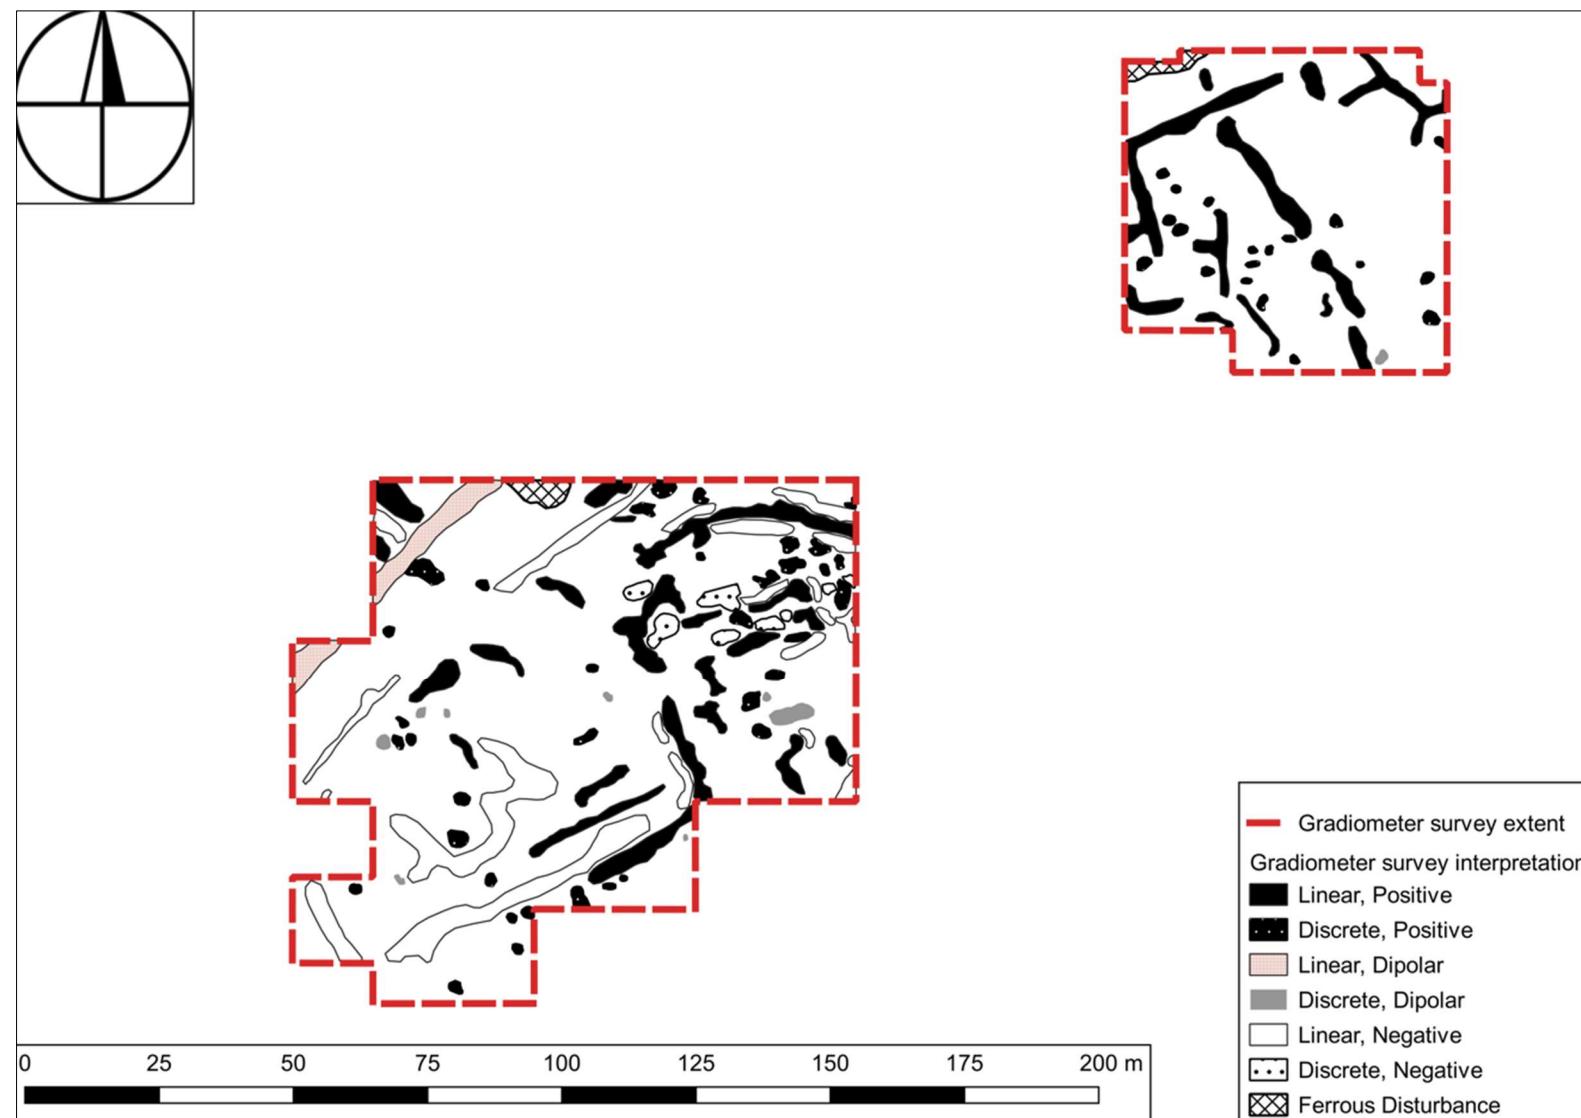
Figure 29: Interpretation of anomalies identified in the gradiometer data.

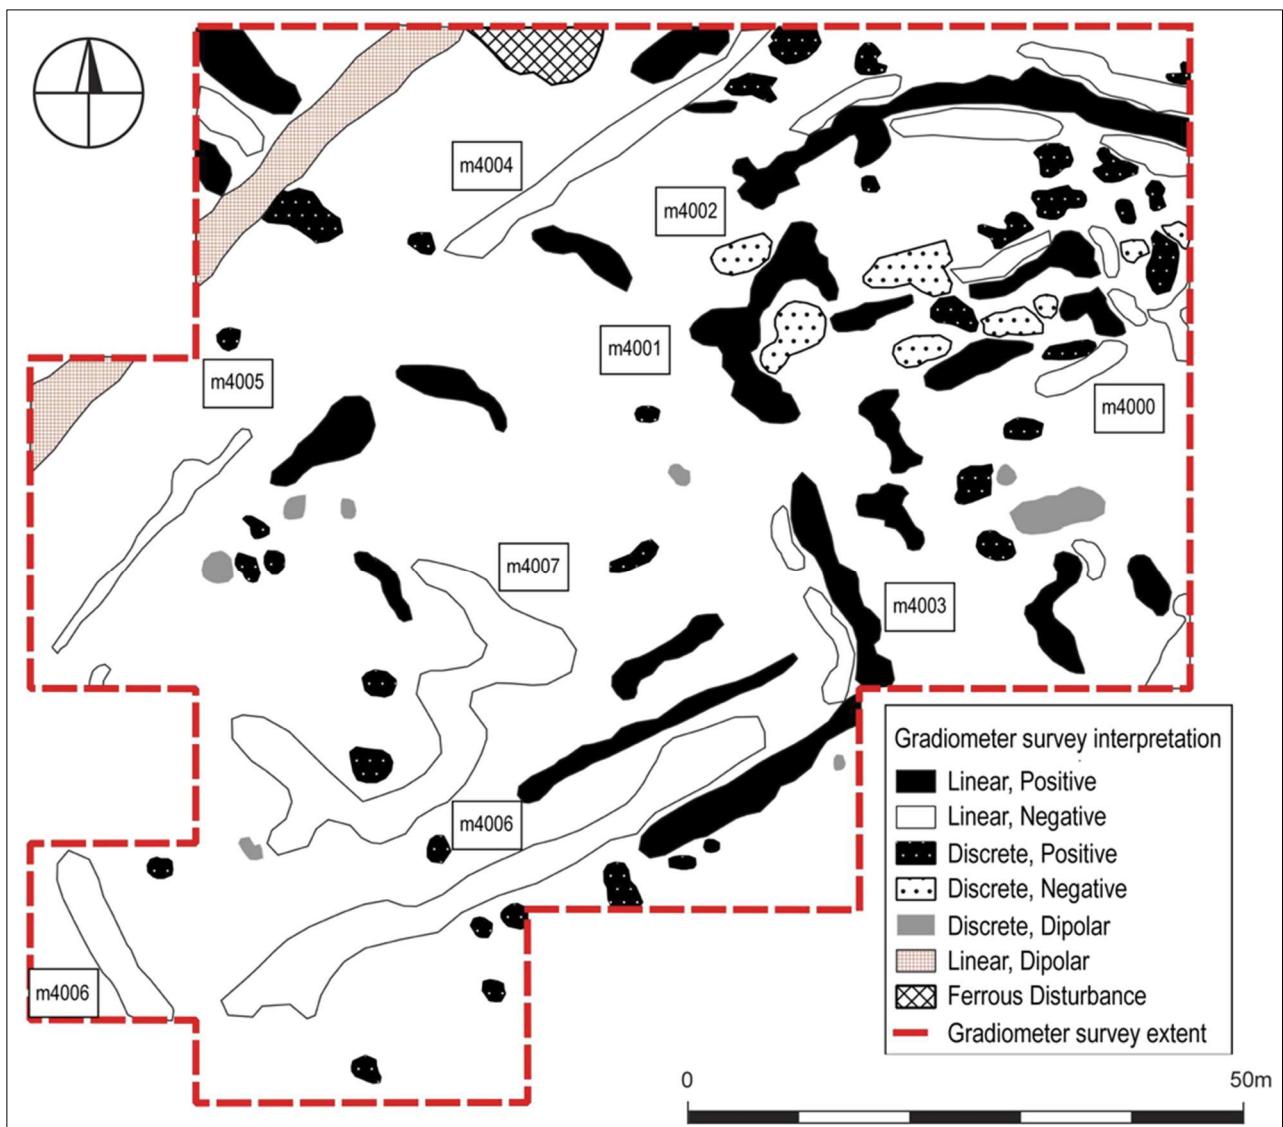
Figure 30: Annotated interpretation of gradiometer survey Area A, south-west of the church.

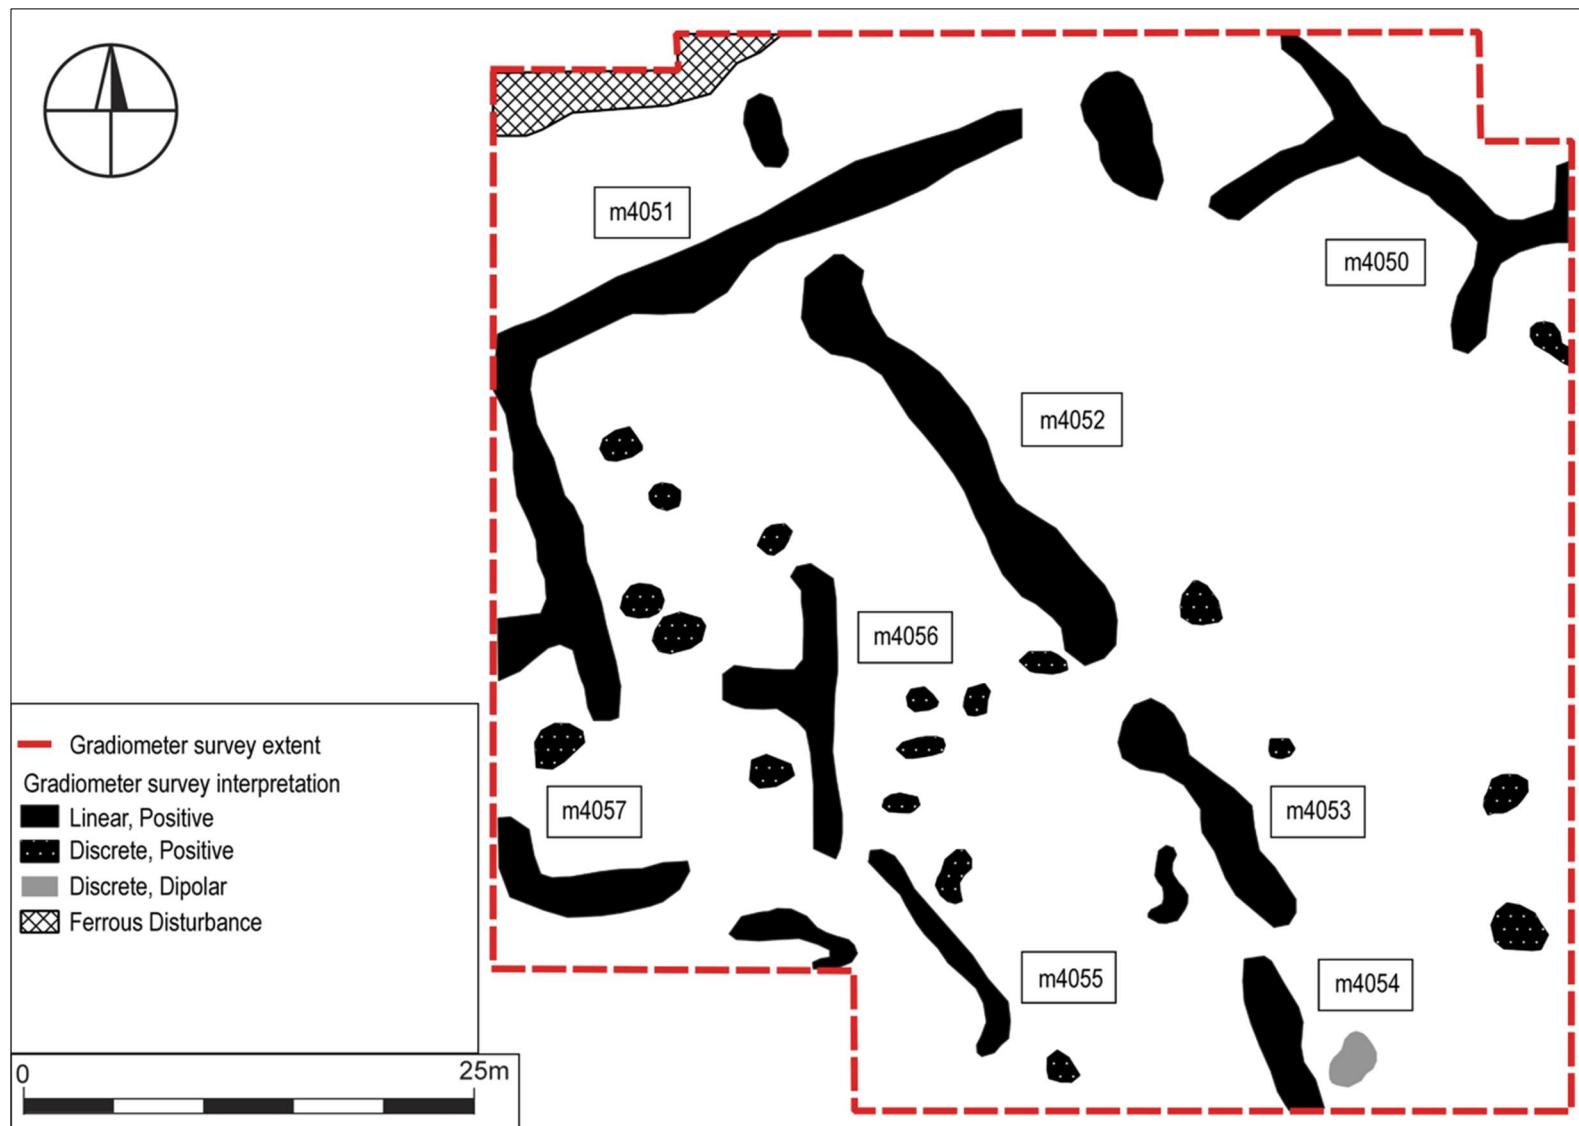
Figure 31: Annotated interpretation of gradiometer survey Area B, north-east of the church.

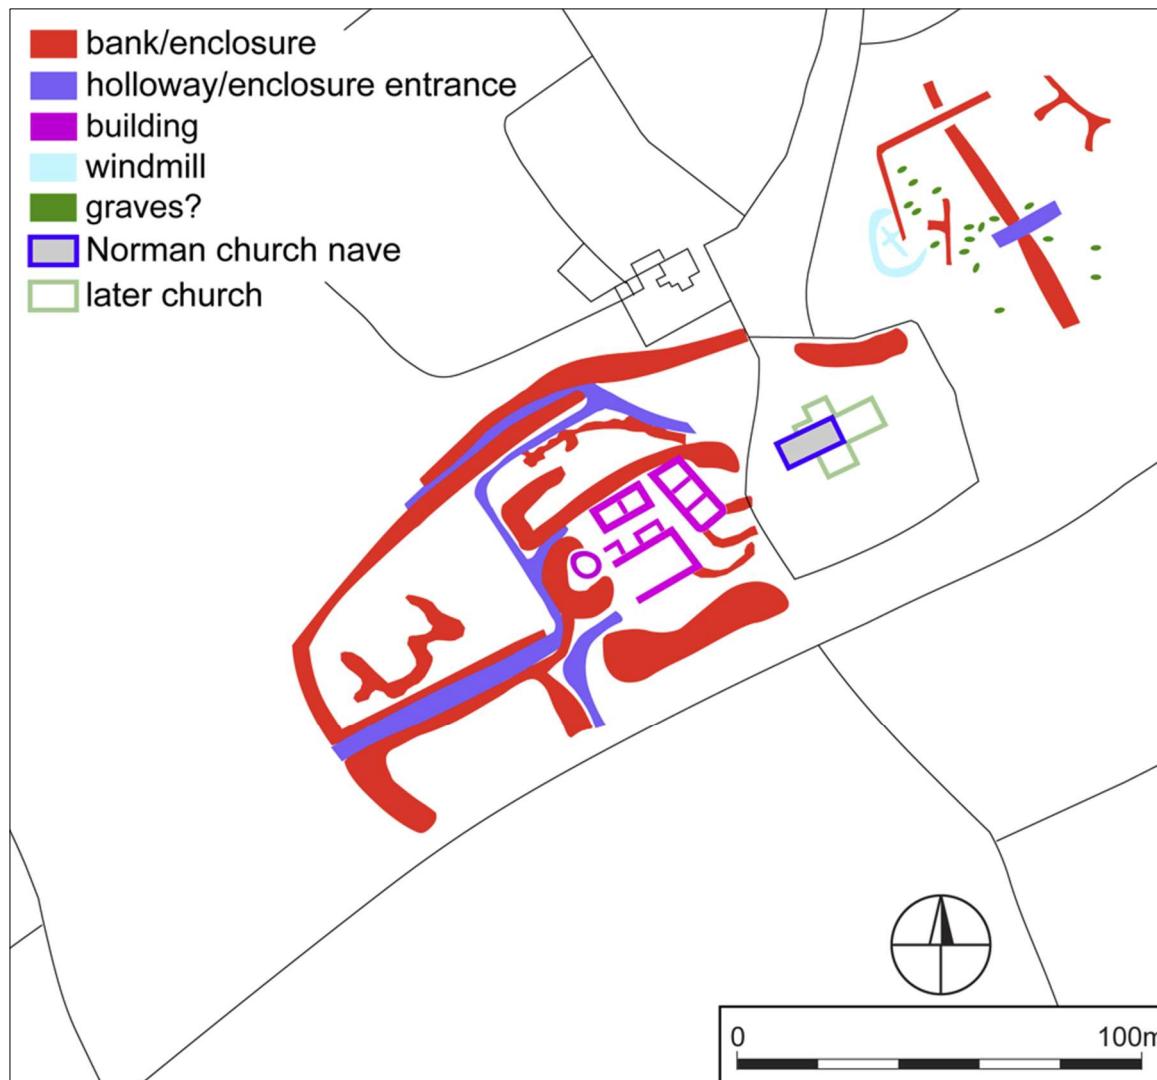
Figure 32: Schematic plan of features identified by topographic and gradiometer surveys, including conjectured interpretations. © Crown Copyright and Database Rights. Ordnance Survey (Digimap Licence).

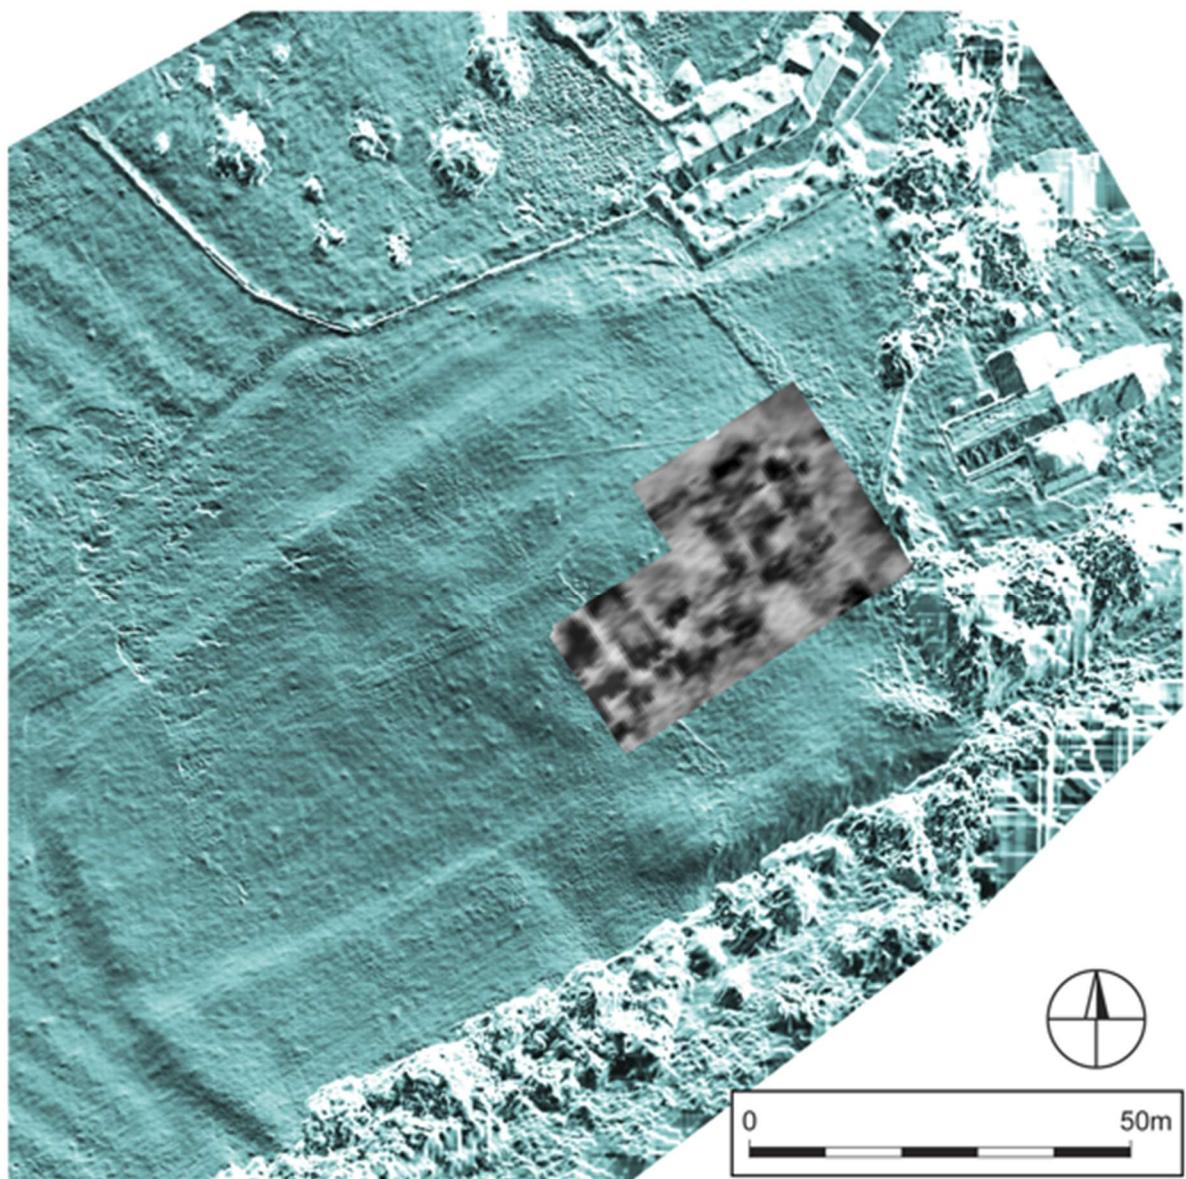
Figure 34: Plot of earth resistance data. Dark areas represent high resistance anomalies, and light areas low resistance anomalies.

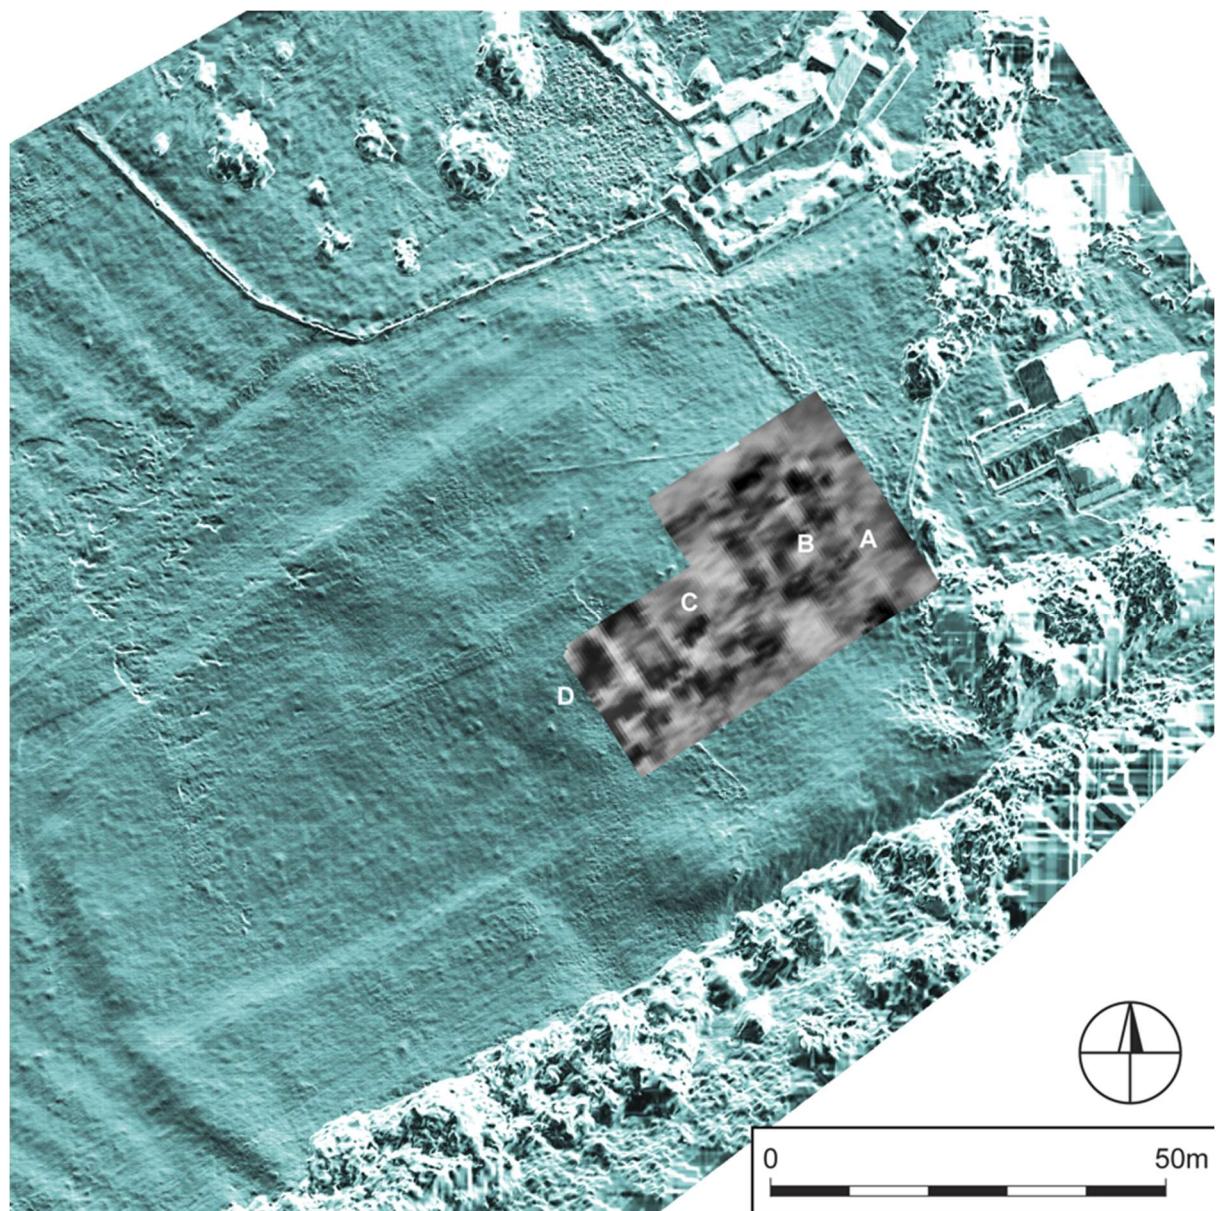
Figure 35: Annotation of anomalies identified by the earth resistance survey.
