Archaeological Investigations at Saintbury, Gloucestershire

By Duncan Wright, Scott Chaussée, Oliver Creighton, David Gould,
Tim Kinnaird, Michael Shapland, Aayush Srivastava, and Sam Turner

June 2024

ARCHAEOLOGICAL INVESTIGATIONS AT SAINTBURY, GLOUCESTERSHIRE

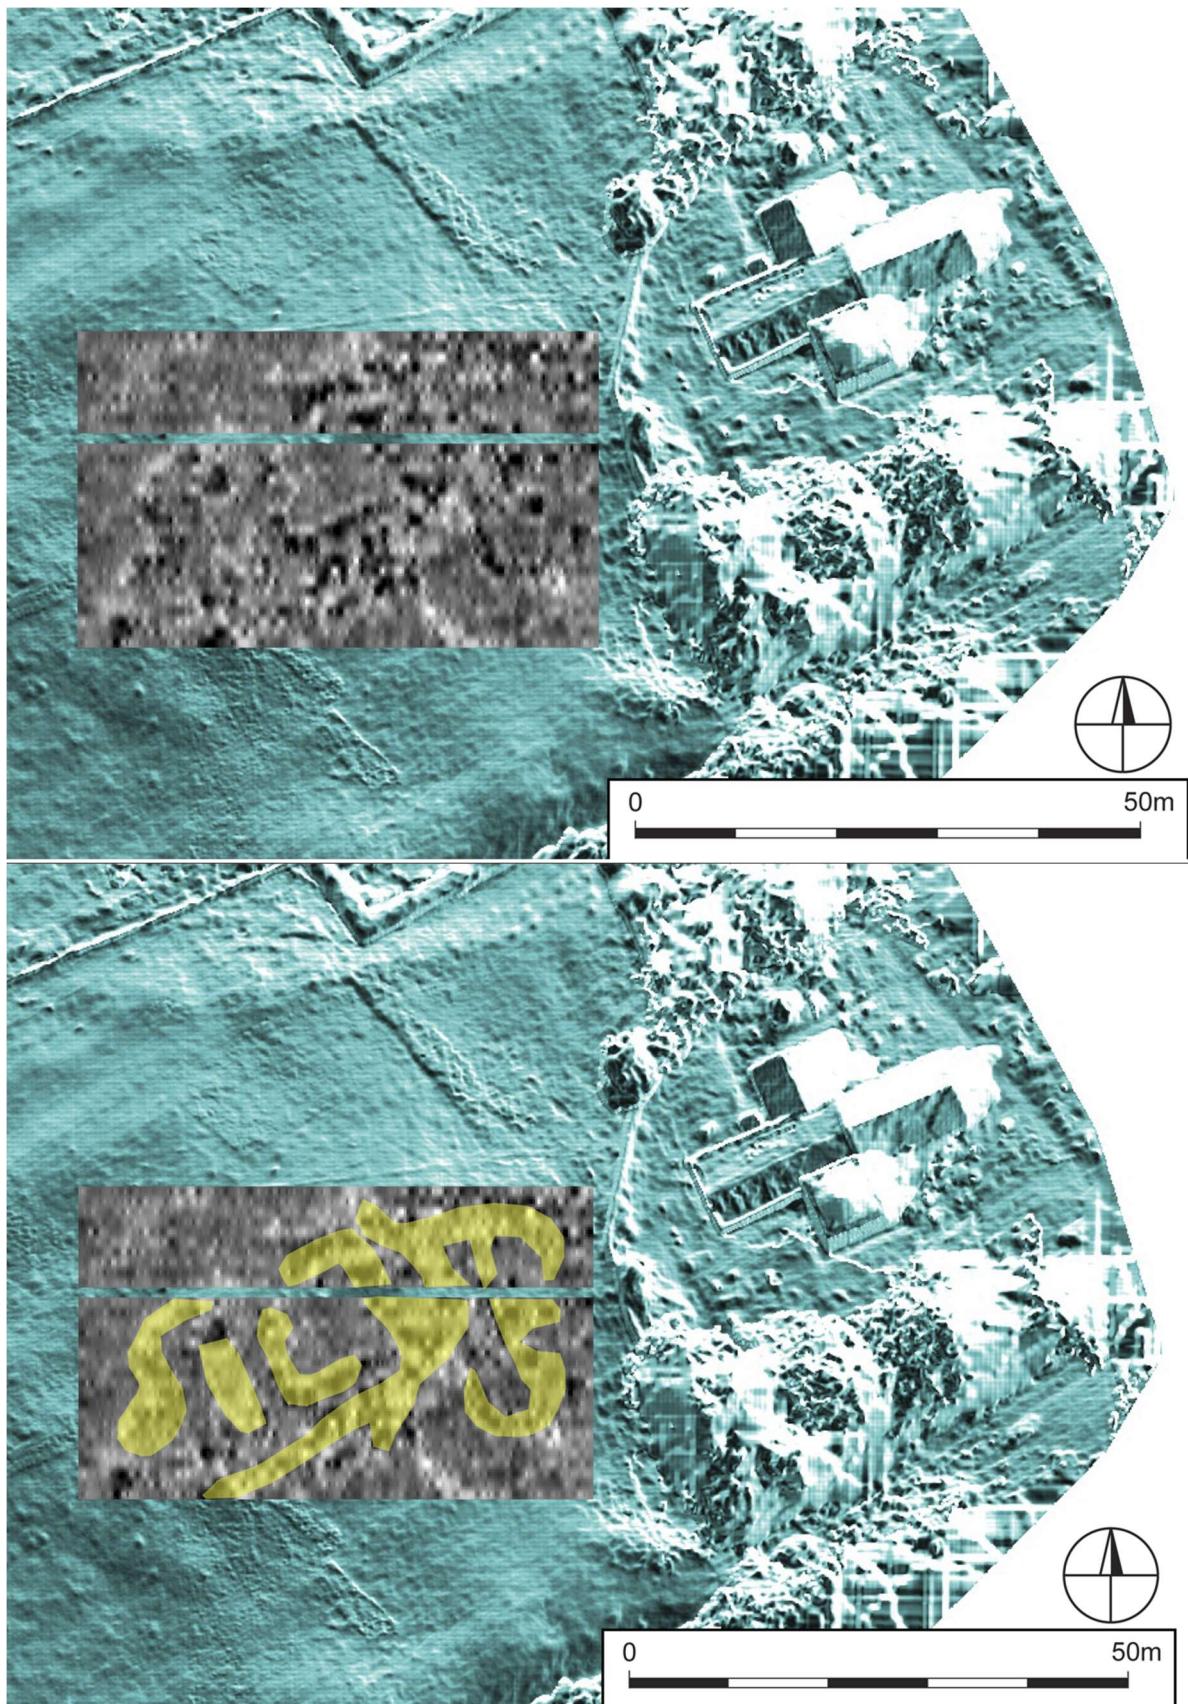
Figure 36: Raw plot of anomalies at TS03 (above) and interpretation (below) located by the GPR. These features are located at a depth of c.0.4-0.6m below ground surface.

For the low frequency antenna, the propagation velocity was established to be 0.1m/ns (Table 1). Time-slice (TS) 03 and 07 returned data consistent with probable archaeological features. A series of anomalies has been identified in TS03, located between 0.4m and 0.6m below the ground surface. These anomalies comprise a complex, coaxial arrangement of linear features which reflect alignment and positioning of earthworks visible in the UAV survey, and the magnetic anomalies observed in the gradiometer survey (Figures 36-37). The most prominent of these features is a central rectilinear feature, enclosing an area with internal dimensions of 9.15m x 8.40m. This clearly correlates with feature 'C' located by the earth resistance survey. The responses in TS03 also closely resemble the extent and morphology of the observed magnetic anomalies observed in the gradiometer data. The rather uneven distribution of the anomalies that make up this feature suggests that it may be a spread of rubble, rather than coherent walls as indicated by earth resistance. Even so, the rectilinear form of the anomalies

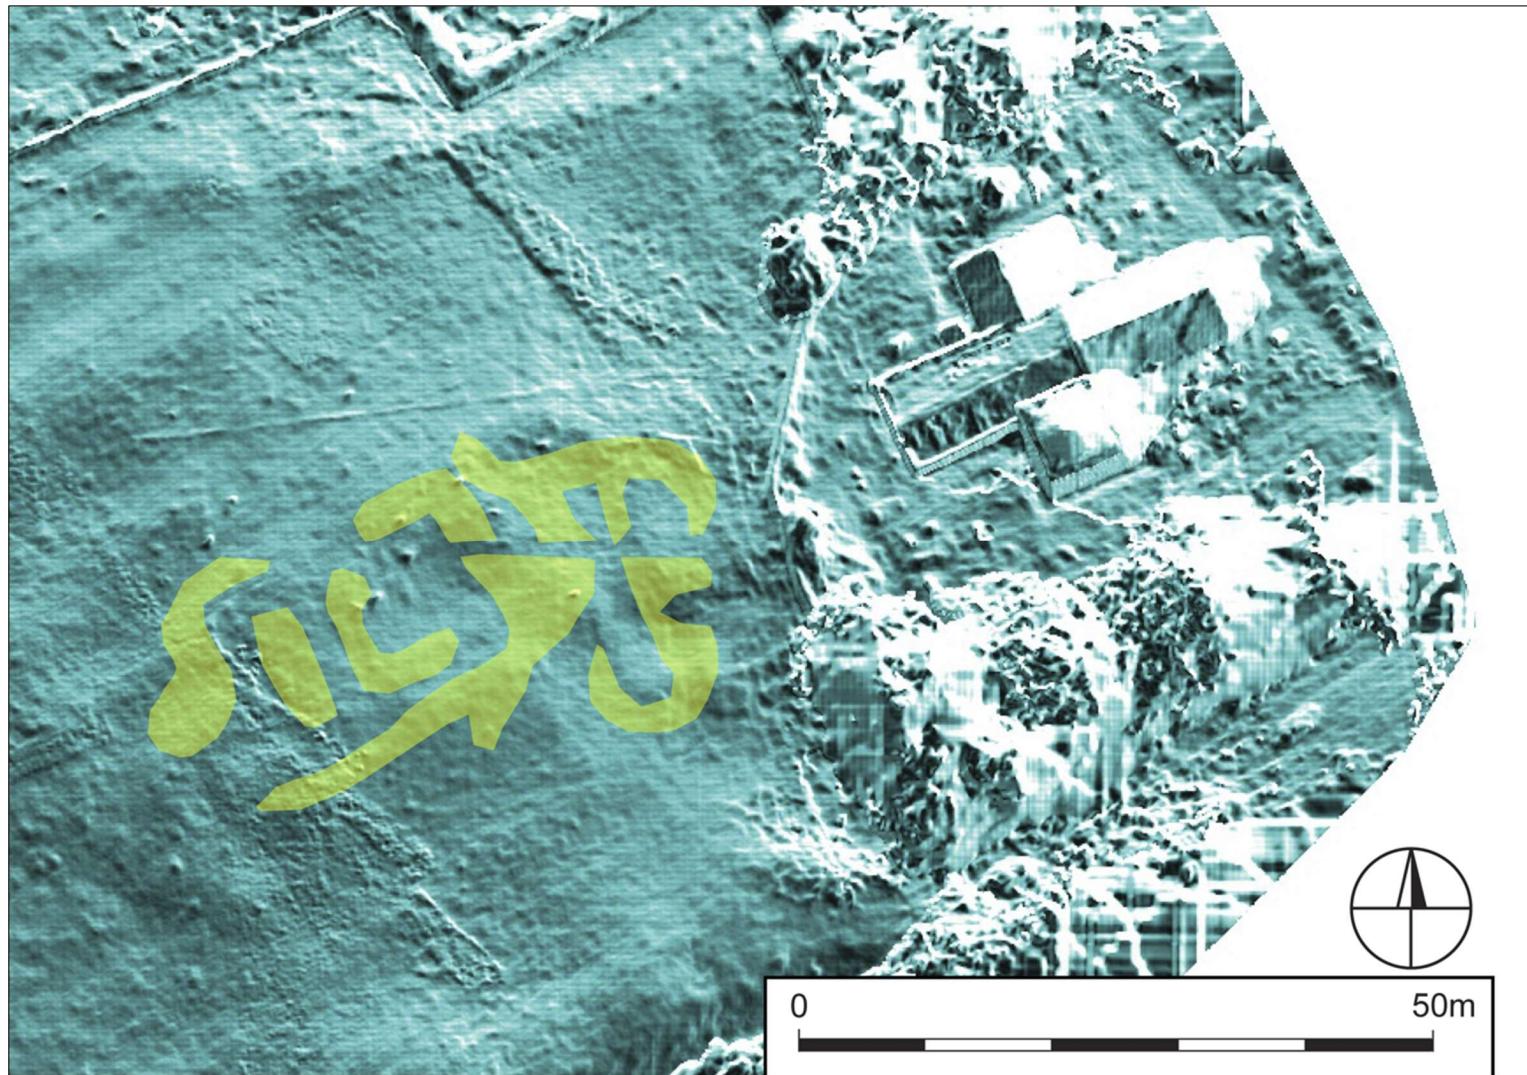
Figure 37: Interpretation of anomalies at TS03, overlaid on the DTM model. Several of the anomalies clearly correlate to upstanding earthworks.

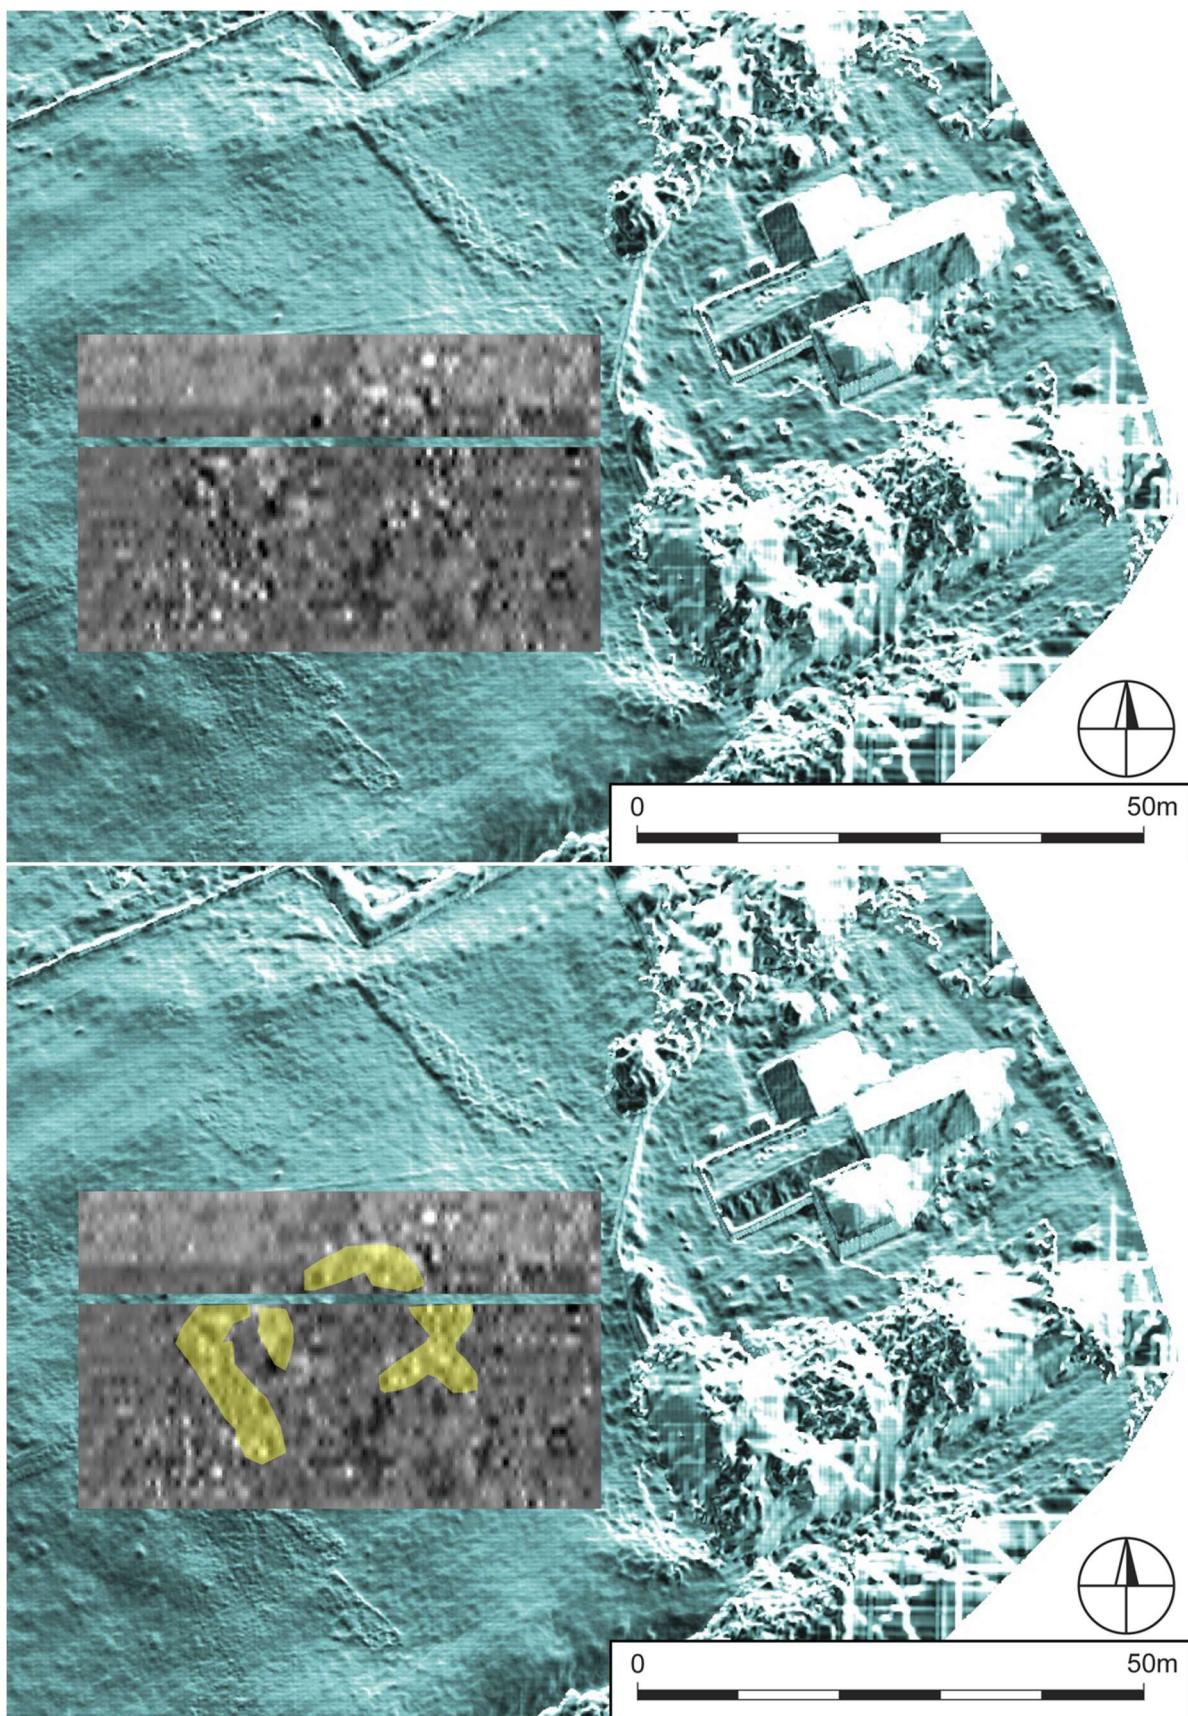
Figure 38: Raw plot of anomalies at TS07 (above) and interpretation (below) located by the GPR. These features are located at a depth of c.1.2-1.4m below ground surface.

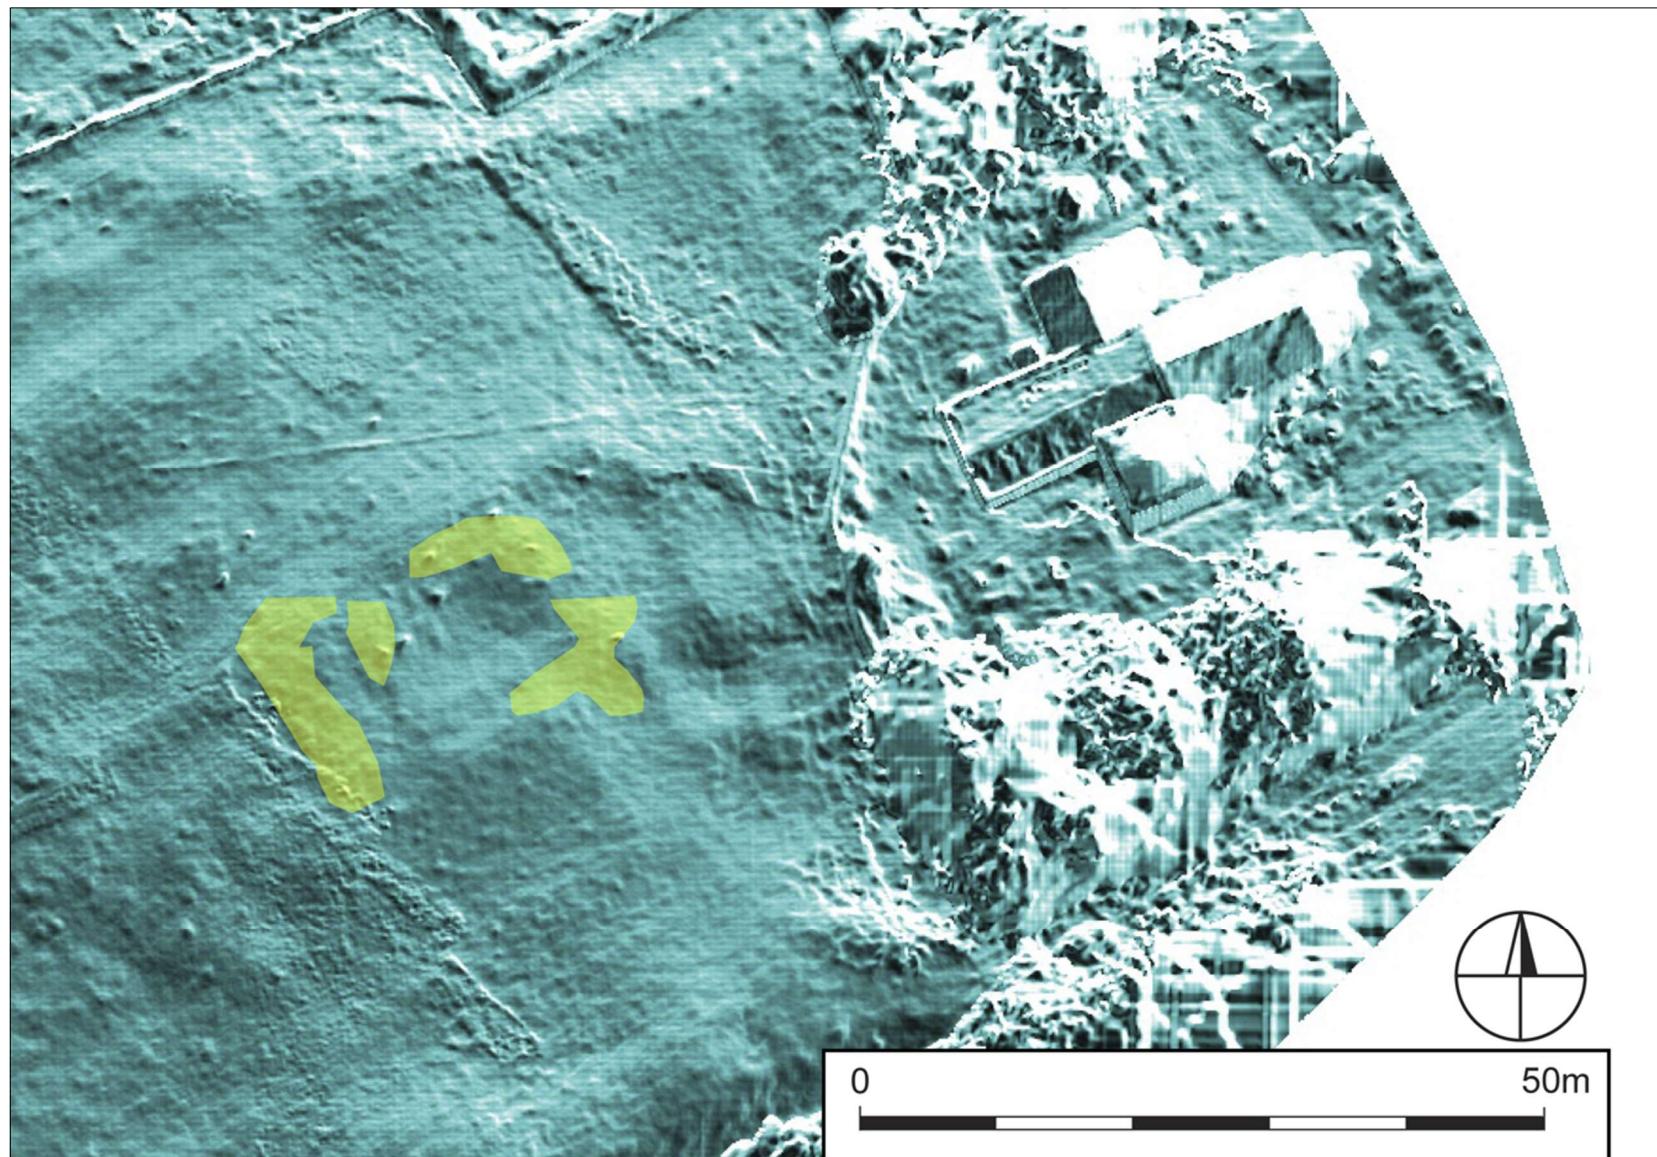
Figure 39: Interpretation of anomalies at TS07, overlaid on the DTM model.

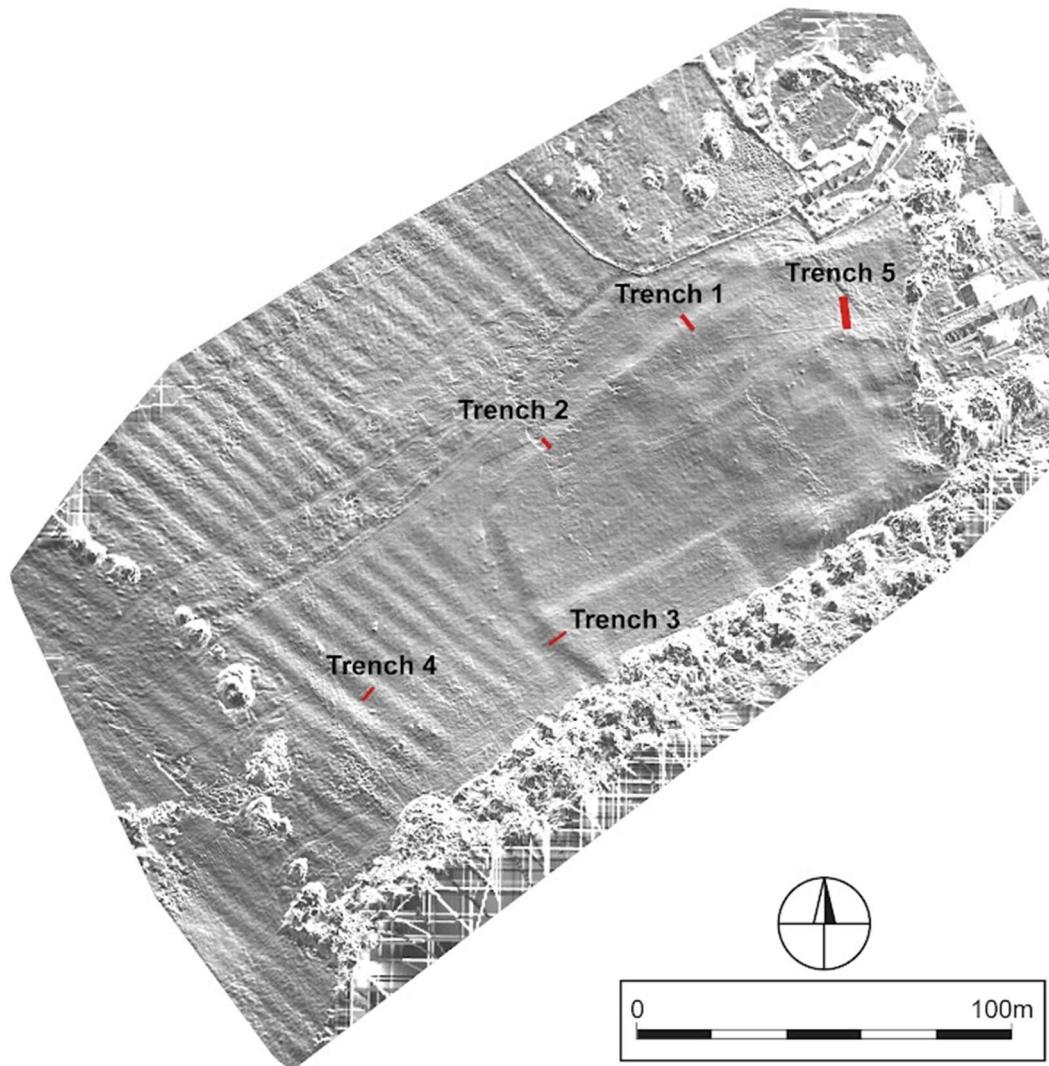
Figure 40: Location of trenches excavated to obtain samples for OSL profiling and dating.

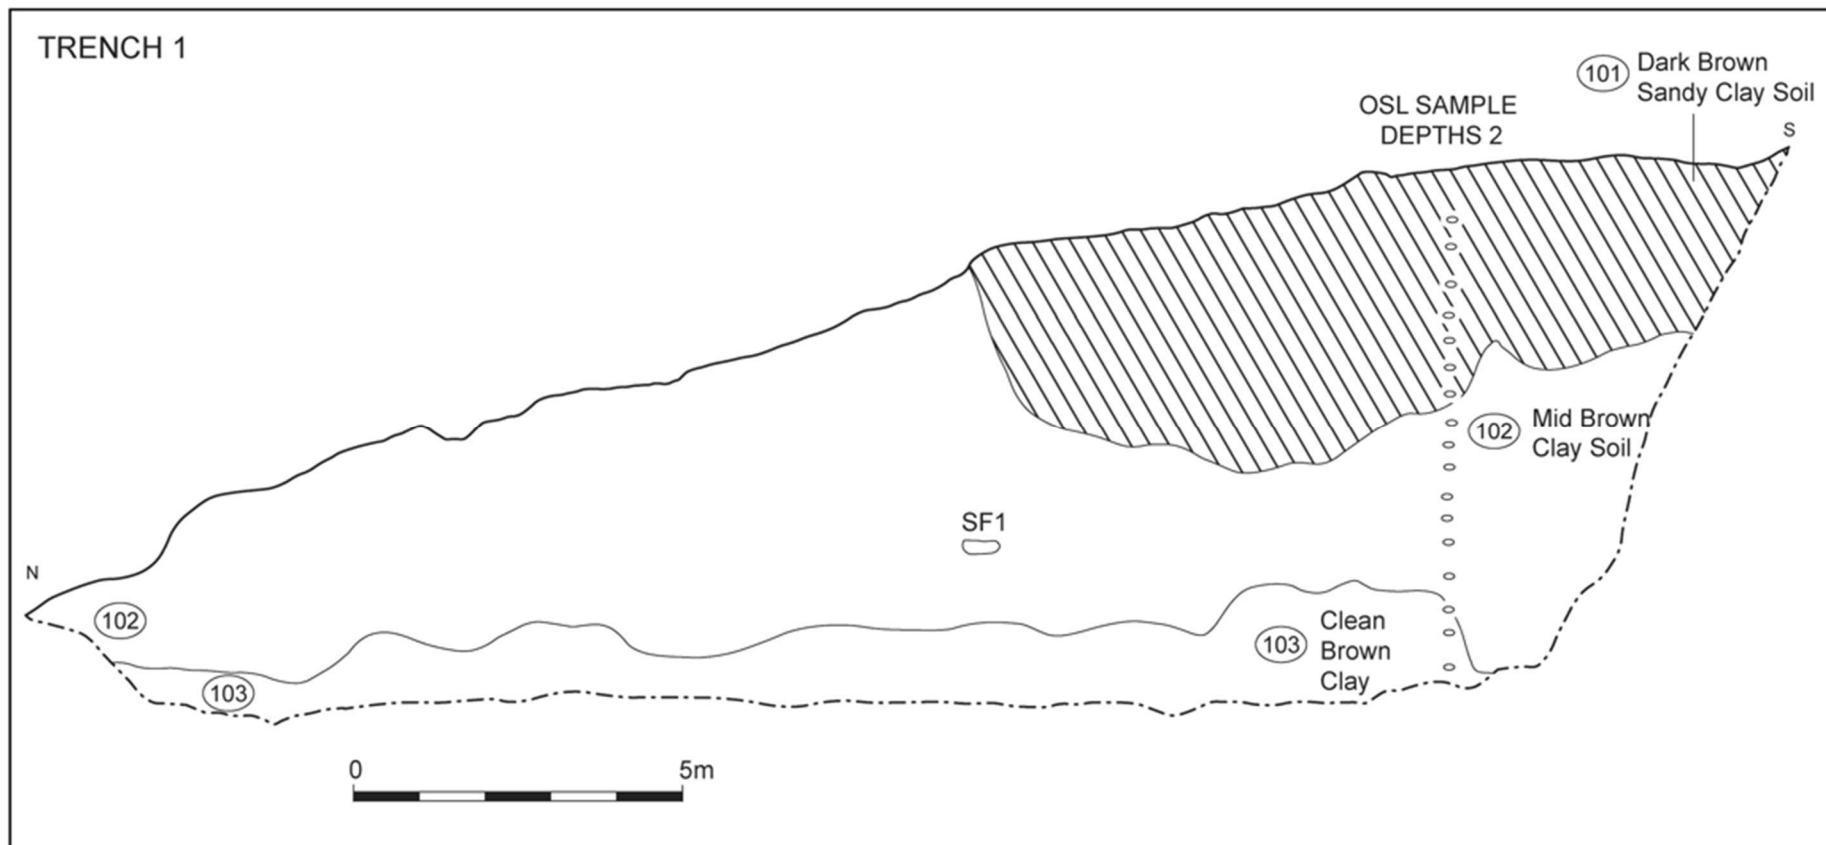
Figure 42: The west-facing section of Trench 1, showing visibly-identified archaeological contexts, OSL sample depths, and the location of a small find of pottery (SF1).

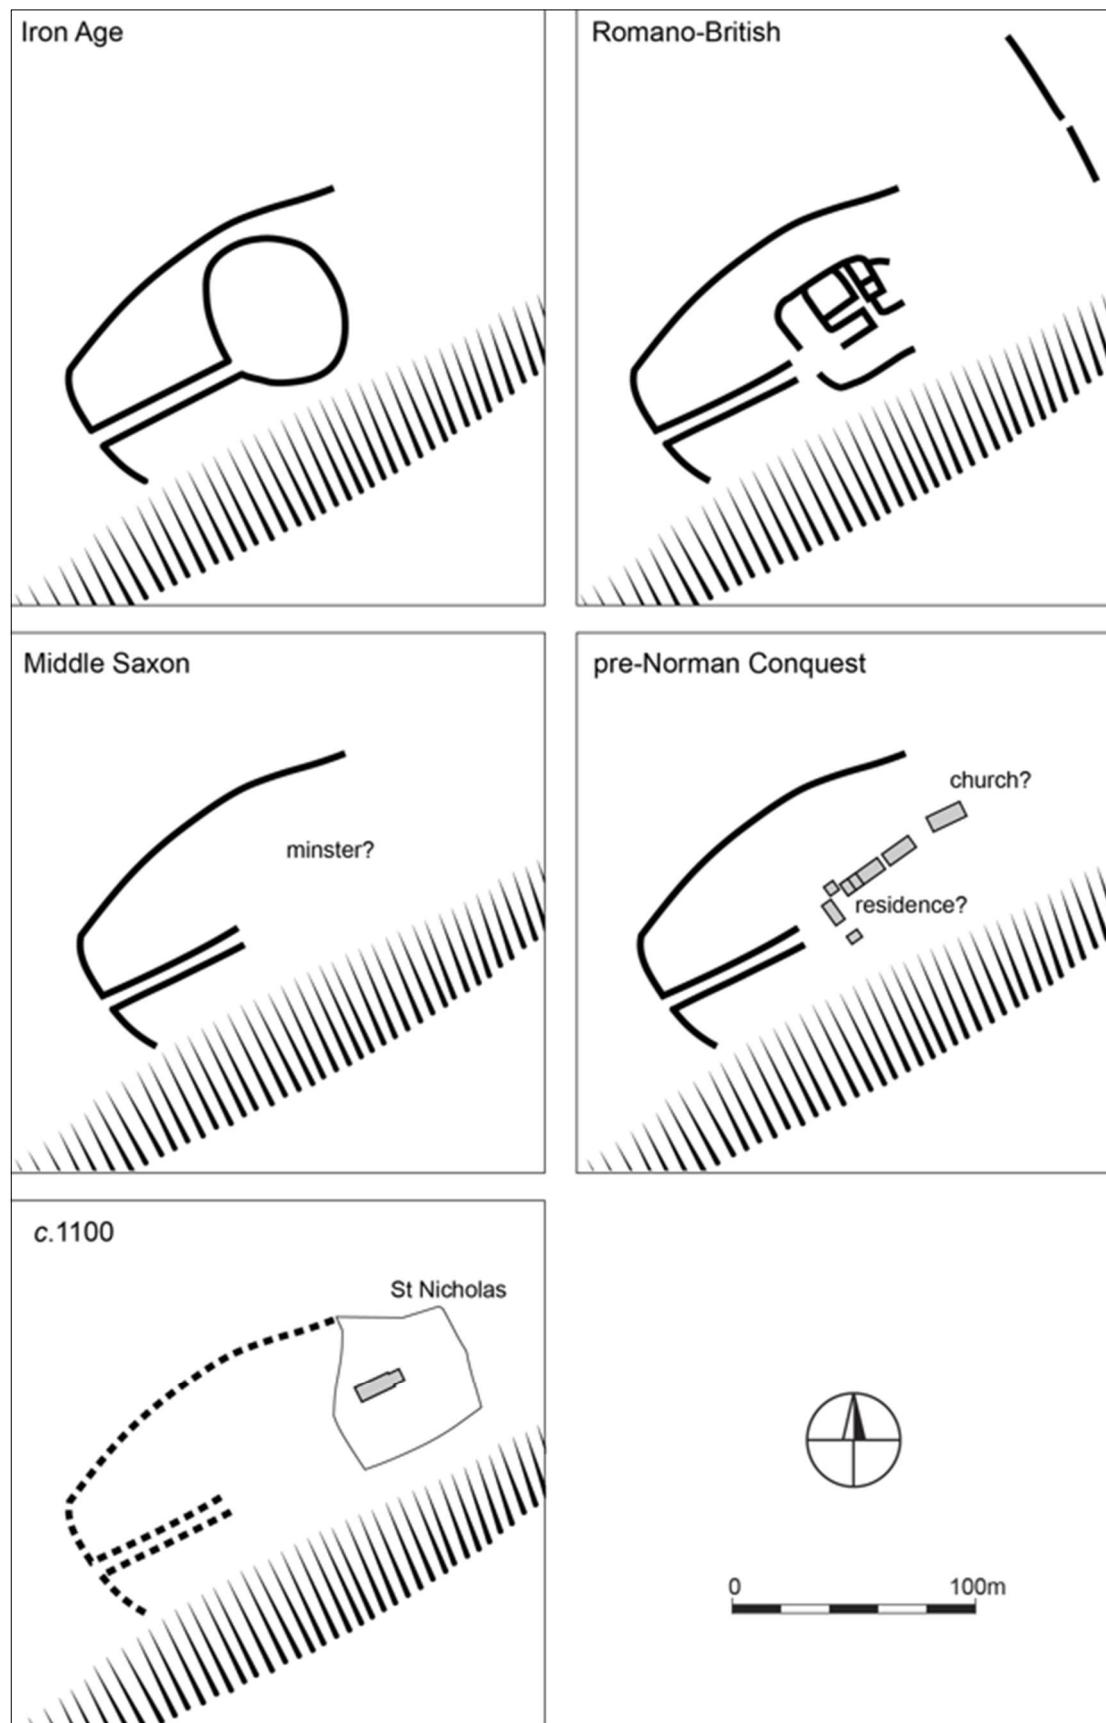
Figure 43: Conjectural phase plan of Saintbury's archaeological development.

reused following a period of abandonment; either way, many of the features that make up the inner network of earthworks and geophysical anomalies seem Roman in origin, possibly representing a villa or other rural settlement, although a military installation or temple cannot be discounted entirely. That the sites of banjo enclosures were reutilised in the Romano-British period is well established, although in such cases the Iron-Age features are consistently abandoned to be replaced by new buildings and enclosures (see Lang 2016, 348-51). We could also be seeing this at Saintbury, where the inner ditch of the curving banjo enclosure seems to be truncated by later rectilinear features, although the large outer earthwork was clearly retained. It is notable that there are several excavated villa complexes built in the immediate vicinity of banjo enclosures (e.g. Harding 2007) in England and south Wales, which perhaps strengthens the case for a high-status rural settlement at Saintbury in the Romano-British period, over the other possible interpretations offered above. Whatever the character of the Roman activity, it is important not to study the dense, well-preserved archaeology south-west of the church in isolation; further features of similar character, albeit not standing as earthworks, are present north-east of the church signifying contemporary occupation. The structural remains south-west of the church could therefore represent a westerly concentration of a far more extensive complex, much of which lies under St Nicholas' (Figure 43).

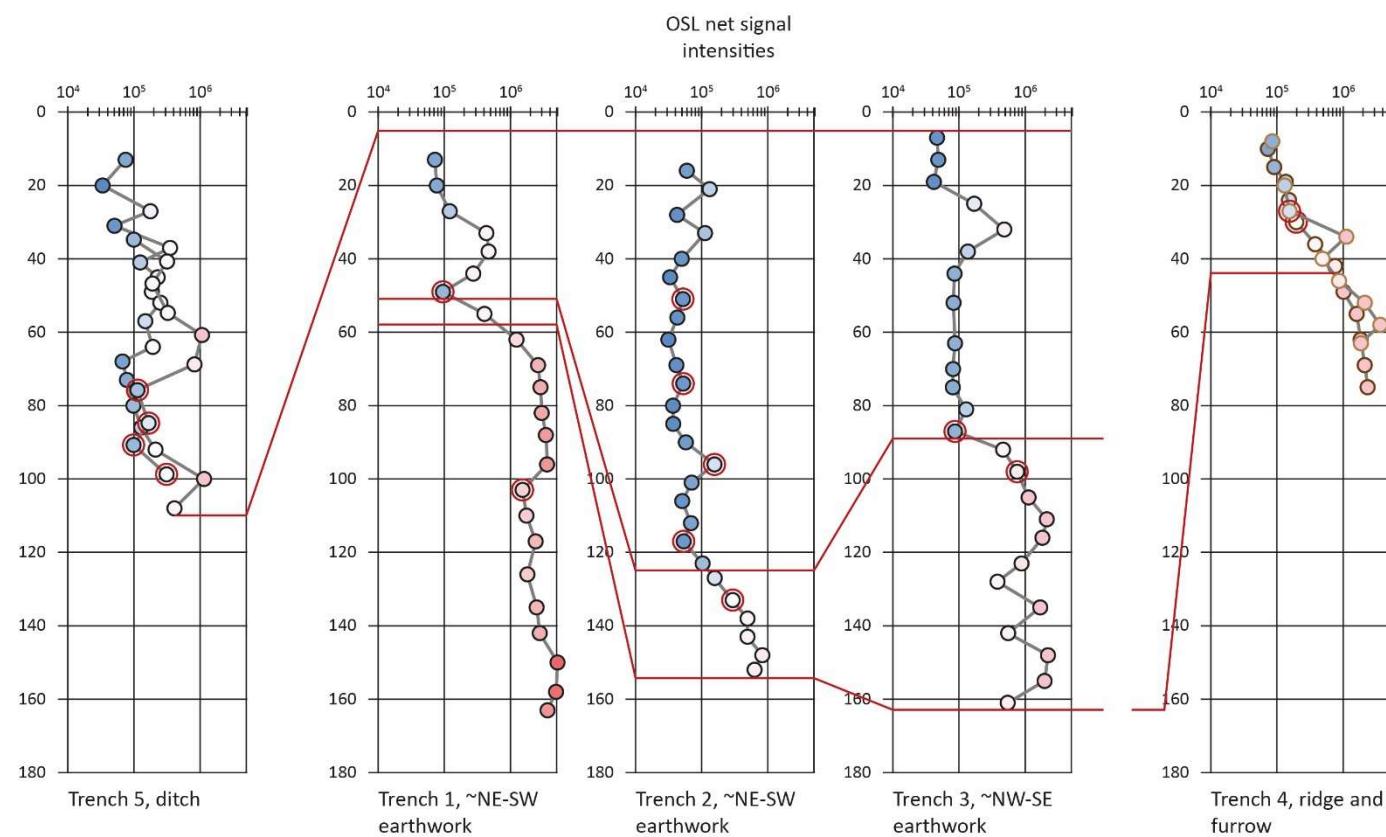
Figure 2: The distribution in OSL signal intensities across the slope: trenches 1, 2 and 3, sectioned the earthwork and substrate; trench 4, a ridge and furrow; and trench 5, the fill of a ditch

Figure 2 illustrates the distribution in OSL net signal intensities observed across the slope: the relative stratigraphies to the earthwork(s) (into substrate) are shown in the middle plots, with some broad correlations drawn from the intensities; the relative sequence to the ditch fills is shown on the left; and the stratigraphy of both the ridge and furrow on the right. The ditch is cut through the substrate, to bedrock. The ridge and furrow modifies the slope below the earthwork. These values are tabulated in Appendix A, together with the corresponding IRSL intensities, IRSL and OSL depletion indices and IRSL:OSL ratios.

The profiles taken through the ditch are more complex, with the multiple fills characterised by discrete signal-depth progressions or signal inversions. These are indicative of change in the depositional processes, from alternating fast/slow to much slower aggradational dynamics. Fortunately for dating, the basal fill in the axis of the ditch is characterised by lower signal intensities than observed up profile, 1.1×10^5 to 9.7×10^4 counts – it likely represents a slow sedimentation, reset at deposition.

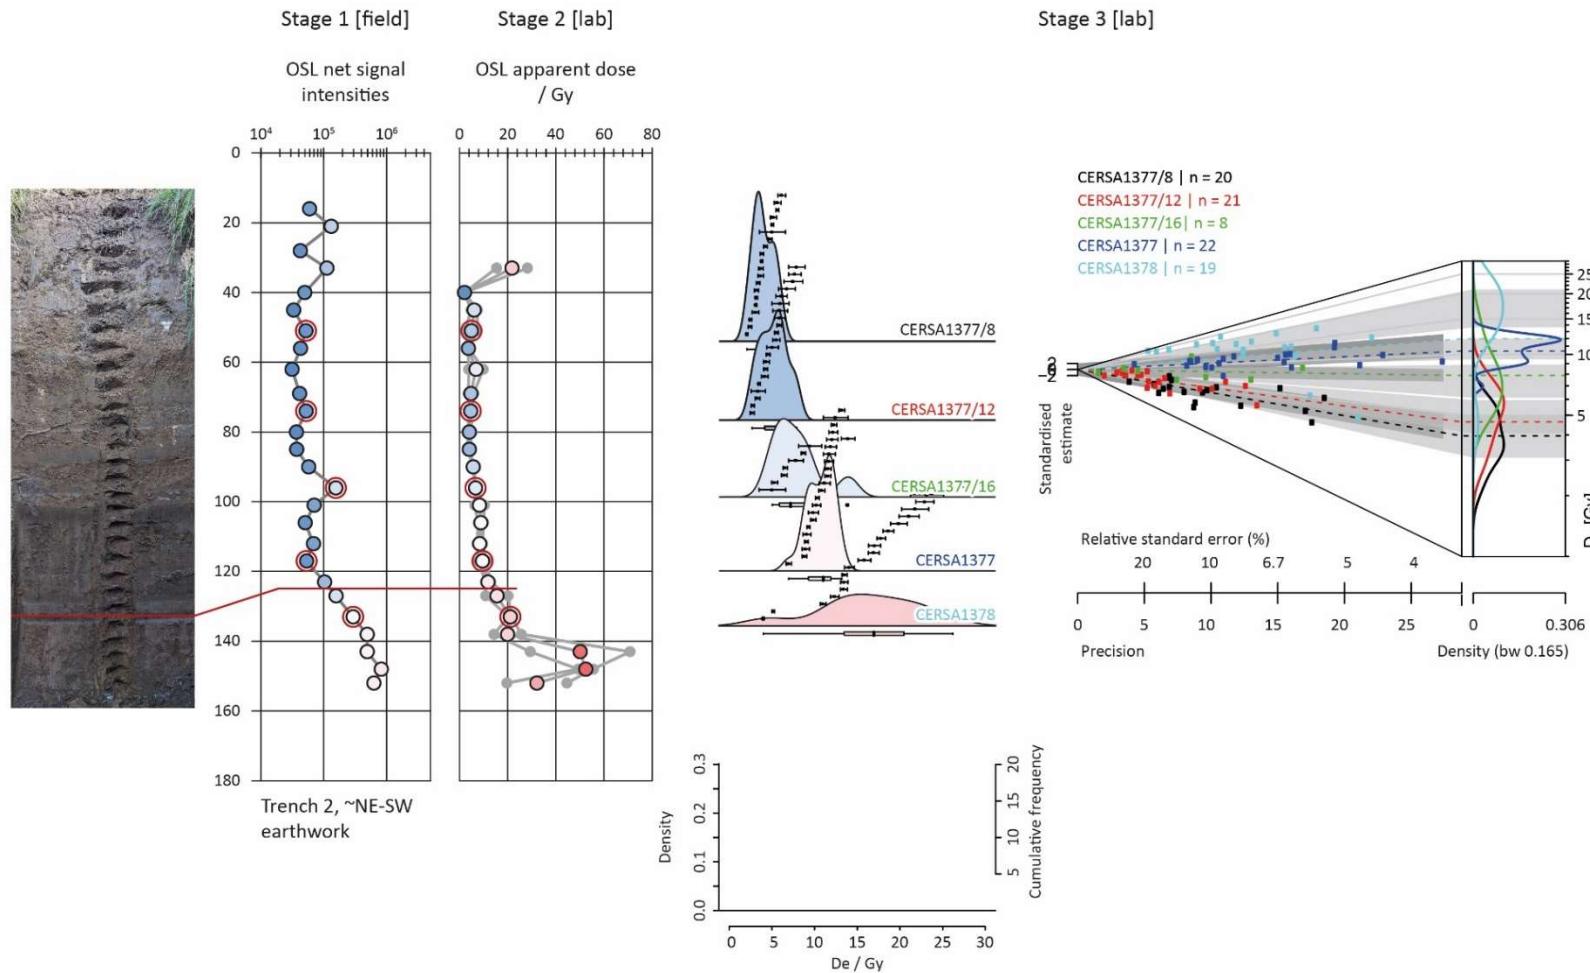
Figure 3: relative luminescence stratigraphies for the sediment revealed in trench 2; illustrating the progression from stage 1 (preliminary screening in the field), through stage 2 (laboratory characterisation) to stage 3 (quartz SAR OSL dating)

The middle plots are Kernel Density Estimate plots showing the distributions in equivalent dose for each sample, plotting these alongside the luminescence stratigraphies

The right hand plot is an Anabico plot, further illustrating the range of distributions

In trench 2, the down-profile trends in apparent dose largely replicate the trends observed in the field profiling dataset (fig 3.). The base of the plough soil is marked by a maxima in apparent dose, >15 Gy (corresponding with a maxima in OSL intensity). Beneath this, through the deposits constituting the bank of the earthwork, apparent doses increase with depth from ~ 2.1 to 6.6 Gy. The substrate is characterised by apparent doses that range from 10.8 to > ~20Gy. Between these, from 101 to 107 cm depth in profile, is a transitional zone – or, diffuse boundary, marked by apparent doses in the range 6.4 to 7.9 Gy. The dating samples, positioned at 117 and 133 cm depth in profile, are located in the part of the profile that might be expected to return ages that trend to geological age. Recognised this, samples from higher in the sequence, at depths of 51, 74 and 96 cm, characterised by apparent doses in the range of 2-3, 4-5 and 6-7 Gy, were progressed to dating in stage 3. These samples should encompass the full sequence to the earthwork, from construction (potentially overprinted with doses that trend to substrate-derived values), to later phasing in its construction.

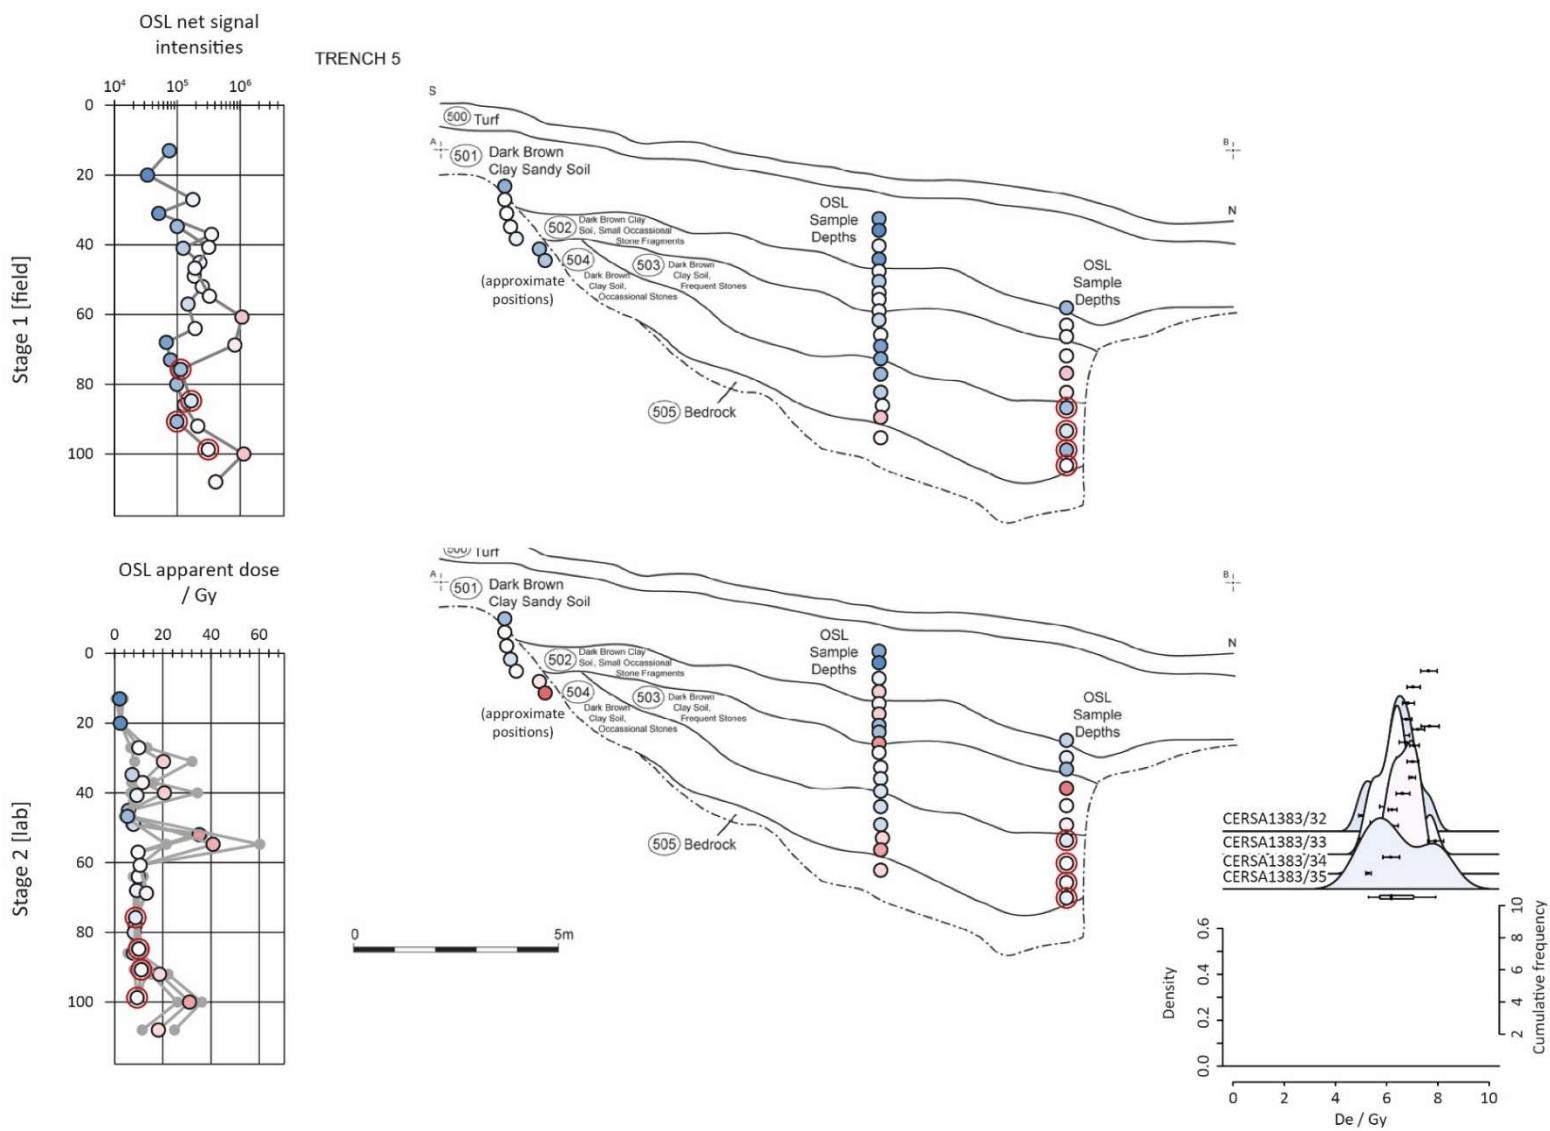
Figure 4: relative luminescence stratigraphies for the sediment revealed in trench 2; illustrating the progression from stage 1 (preliminary screening in the field), through stage 2 (laboratory characterisation) to stage 3 (quartz SAR OSL dating)

A more complex distribution in apparent doses is observed in trench 5. The upper fills to the ditch <502> and <503> are characterised by heterogeneous distributions in apparent dose, ranging from ~ 4 to 27 Gy. These deposits are mixed age. Fortunately - and replicating the earlier dataset set - the lower fill <504> is characterised by more consistent apparent dose values, 4 to 6 Gy, which might
